*CLAYTON HOME INSPECTION, INC.*

Home Inspection Report for:  
John Smith

10 Shore Dr Marshfield Ma

# Wood Destroying Insect Inspection Report

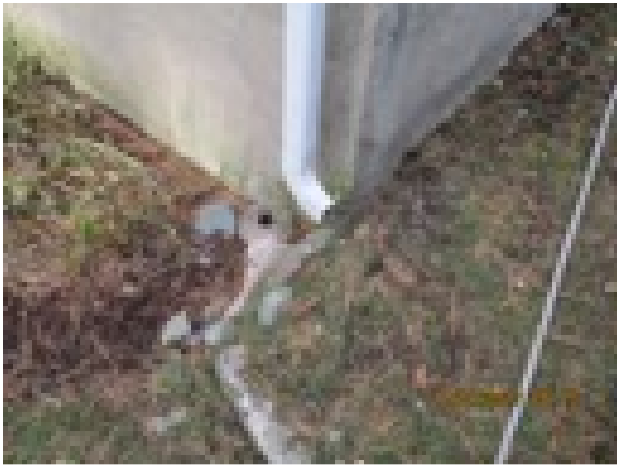
File name IMG\_2215.JPG  
Date of photo: 11/1/2017  
Report Page: Exterior: Grade/Drainage  
Description: Update grading and extend downspouts from structure  
Action: Recommend consult a qualified contractor  
Required: for full evaluation/repairs or replacement.

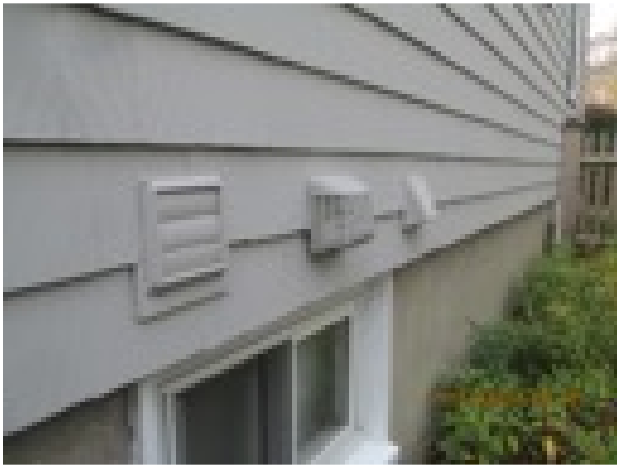
File name IMG\_2216.JPG  
Date of photo: 11/1/2017  
Report Page: Exterior  
Description: multiple vents noted, clean and evaluate  
Action: Recommend consult a qualified contractor  
Required: for full evaluation/repairs or replacement.

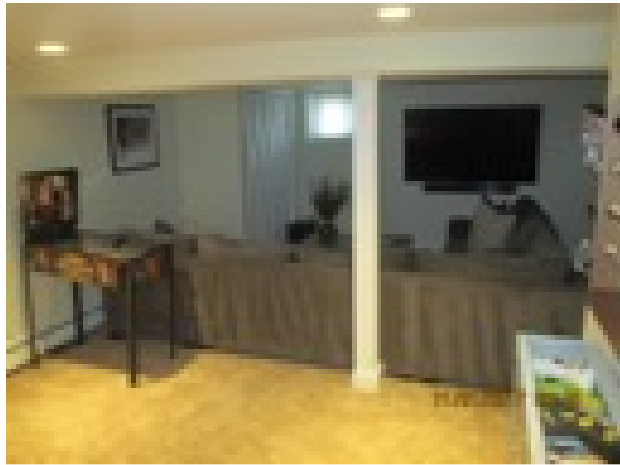
File name IMG\_2260.JPG  
Date of photo: 11/1/2017  
Report Page: Basement  
Description: **Finished basement noted, structure composites not viewed**  
Action: Repairs noted, Obtain any and all statements, documents from all owner(s) /Town Officials/Permits/Contractor(s) who performs repairs and any and all warranties/Guarantees in writing.  
Address of Property: 10 Shore Dr Marshfield Ma

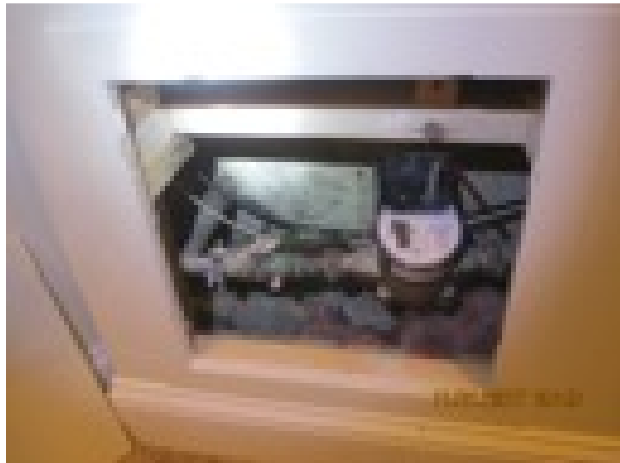
File name IMG\_2261.JPG  
Date of photo: 11/1/2017  
Report Page: Plumbing System  
Description: **Older water main noted is subject to replacement**  
Action: Recommend consult a qualified contractor for full evaluation/repairs or replacement.  
Address of Property: 10 Shore Dr Marshfield Ma

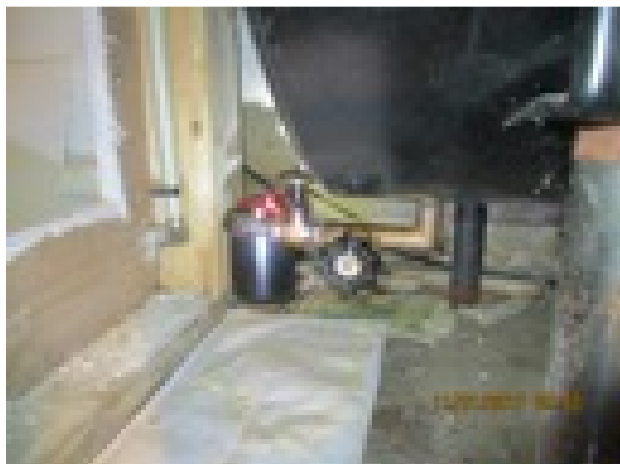
File name IMG\_2267.JPG  
Date of photo: 11/1/2017  
Report Page: Heating System  
Description: **Small stains of oil noted to floor and oil lines noted**  
Action: Recommend consult a qualified contractor for full evaluation/repairs or replacement.  
Address of Property: 10 Shore Dr Marshfield Ma

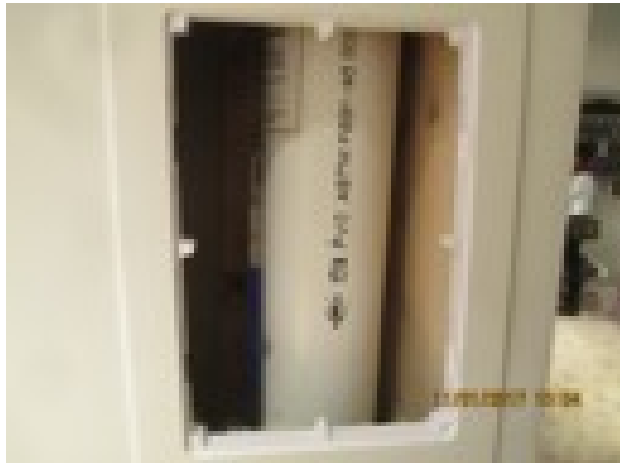
File name IMG\_2283.JPG  
Date of photo: 11/1/2017  
Report Page: Radon setup  
Description: Radon system noted to basement and exterior  
Action: Recommend consult a qualified contractor  
Required: for full evaluation/repairs or replacement.

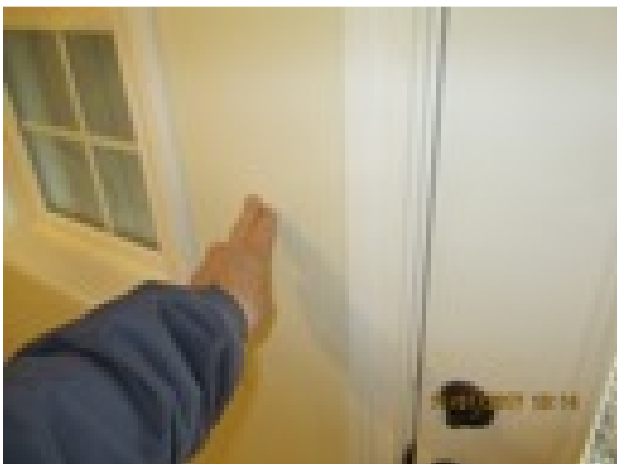
File name IMG\_2300.JPG  
Date of photo: 11/1/2017  
Report Page: Electric System  
Description: Reommend add a switch to rear entry for safety  
Action: Recommend consult a qualified contractor  
Required: for full evaluation/repairs or replacement.

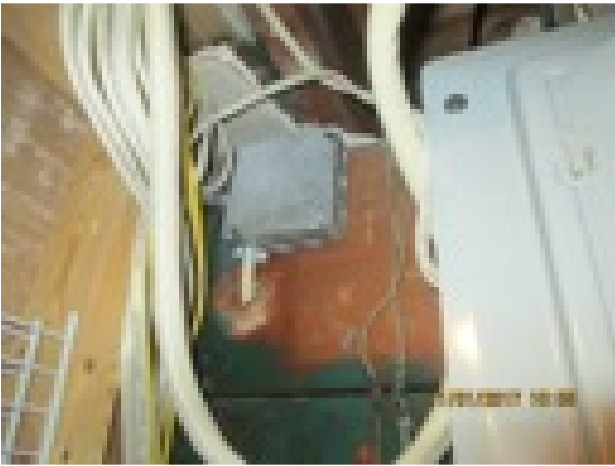
File name IMG\_2345.JPG  
Date of photo: 11/1/2017  
Report Page: Electric System  
Description: Cut disconnected wires noted

Action: Recommend consult a qualified contractor  
Required: for full evaluation/repairs or replacement.

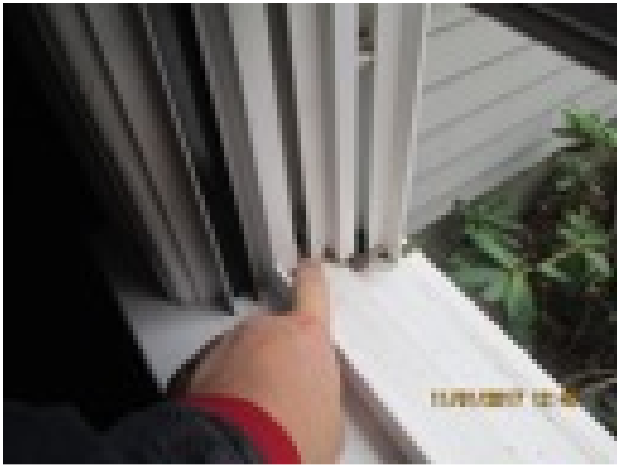
File name IMG\_2437.JPG  
Date of photo: 11/1/2017  
Report Page: Interior  
Description: **Disconnected spring to window front first floor noted**  
Action: Recommend consult a qualified contractor  
Required: for full evaluation/repairs or replacement.

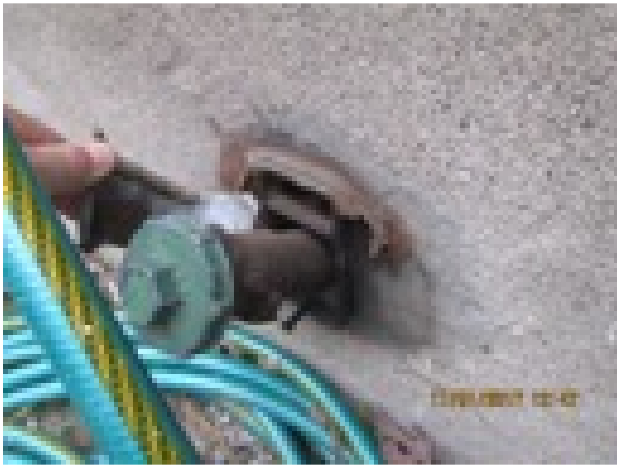
File name IMG\_2439.JPG  
Date of photo: 11/1/2017  
Report Page: Heating System  
Description: **Improper vent can allow water to enter the tank requires repairs/replacement**  
Action: Recommend consult a qualified contractor  
Required: for full evaluation/repairs or replacement.

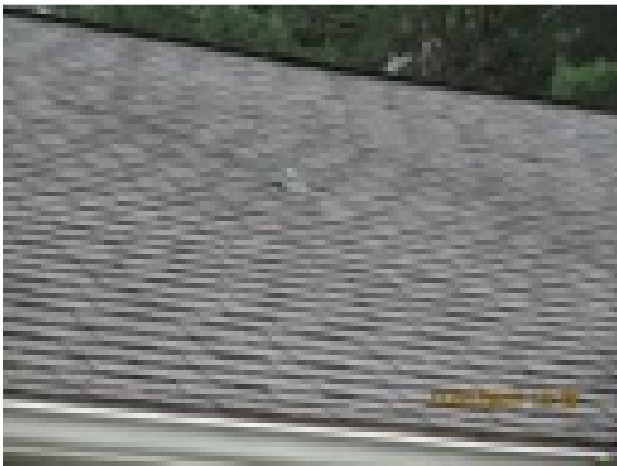
File name IMG\_2441.JPG  
Date of photo: 11/1/2017  
Report Page: Exterior  
Description: **Lifting shingles noted**  
Action: Recommend consult a qualified contractor  
Required: for full evaluation/repairs or replacement.
