CLAYTON HOME INSPECTION, INC.

**Home Inspection Report for:
John Smith**

10 Shore Dr Marshfield Ma

Monday, March 11, 2019

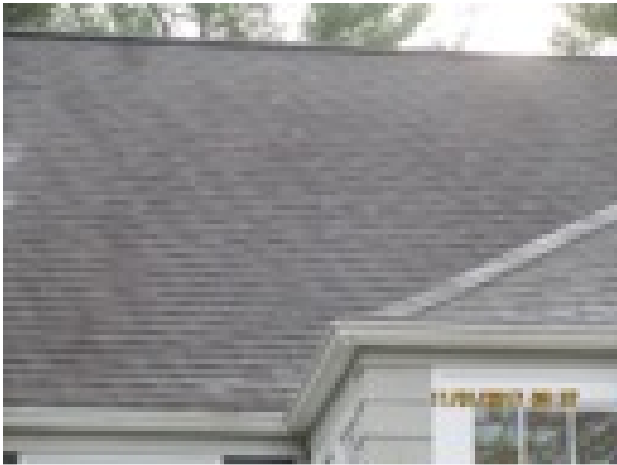
File name IMG_2172.JPG

Description: **Damaged/lifting roof shingles are subject to repairs or replacement**

Less than Satisfactory (Contractor advised)

Action: Recommend consult a qualified contractor
Required: for full evaluation/repairs or replacement.

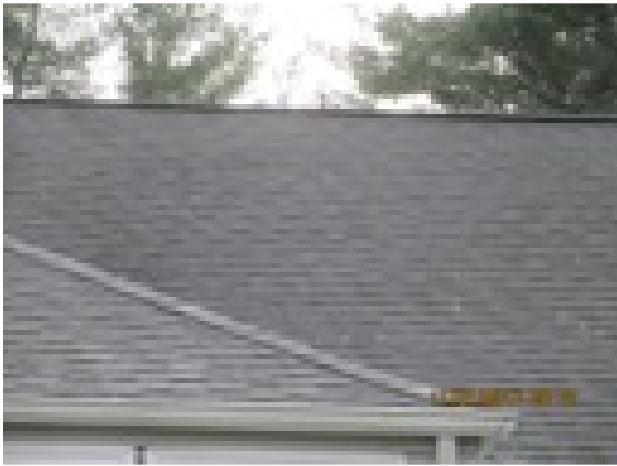
File name IMG_2173.JPG

Description: **Damaged/lifting roof shingles are subject to repairs or replacement**

Less than Satisfactory (Contractor advised)

Action: Recommend consult a qualified contractor
Required: for full evaluation/repairs or replacement.

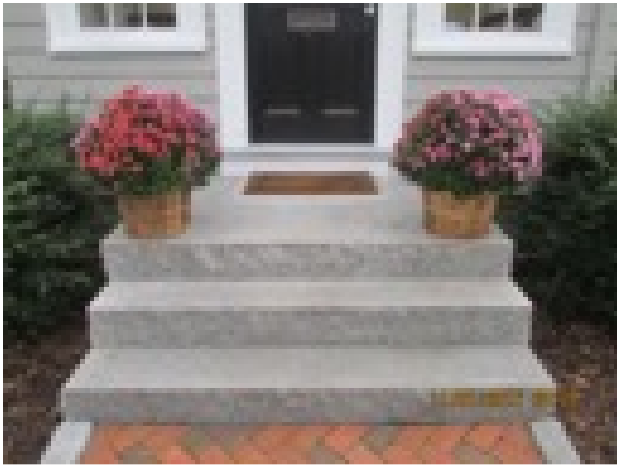
File name IMG_2175.JPG

Description: **Missing flashing between landing and front porch**

Less than Satisfactory (Contractor advised)

Action: Recommend consult a qualified contractor
Required: for full evaluation/repairs or replacement.

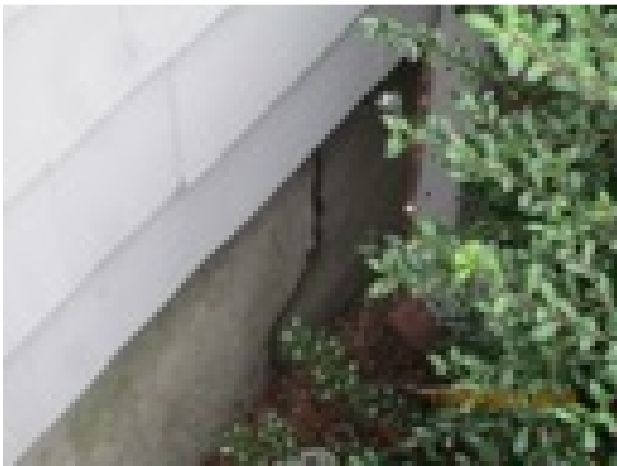
Description: **Foundation cracks noted**

Less than Satisfactory (Contractor advised)

Action: Recommend consult homeowner for history
Required: in writing and or a qualified contractor for full evaluation and repairs or replacement as needed.

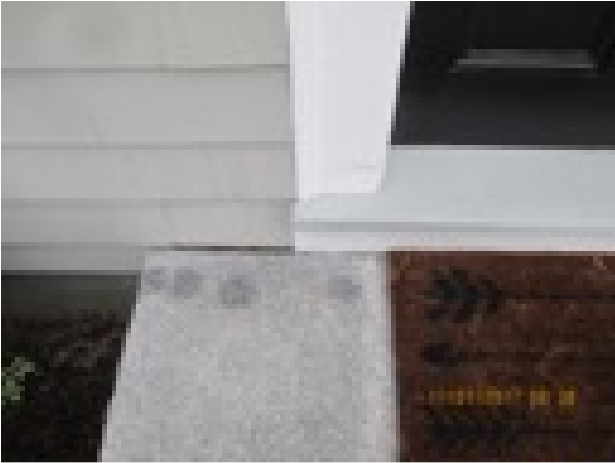
File name IMG_2179.JPG

Description: **Missing flashing between landing and front porch**

Less than Satisfactory (Contractor advised)

Action: Recommend consult a qualified contractor
Required: for full evaluation/repairs or replacement.

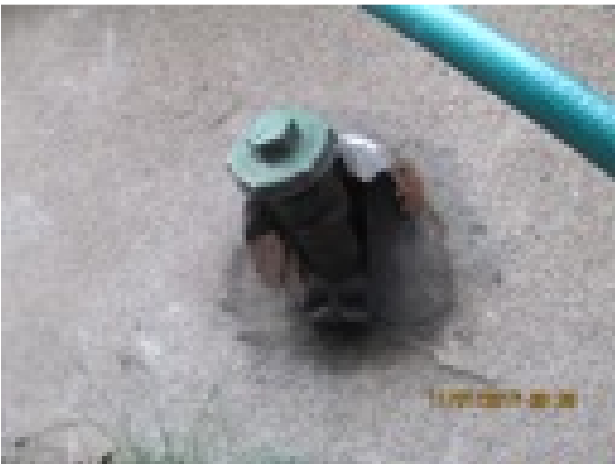
Description: **Improper oil vent at foundation noted**

Less than Satisfactory (Contractor advised)

Action: Recommend consult a qualified contractor
Required: for full evaluation/repairs or replacement.

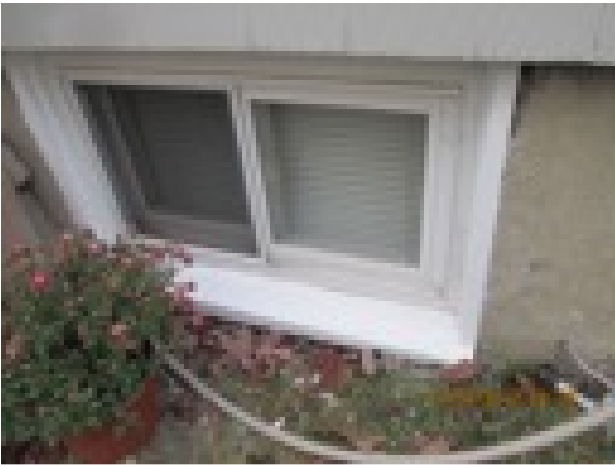
File name IMG_2185.JPG

Description: **Dryrot noted to window earth contact,add a window well**

Less than Satisfactory (Contractor advised)

Action: Recommend consult a qualified contractor
Required: for full evaluation/repairs or replacement.

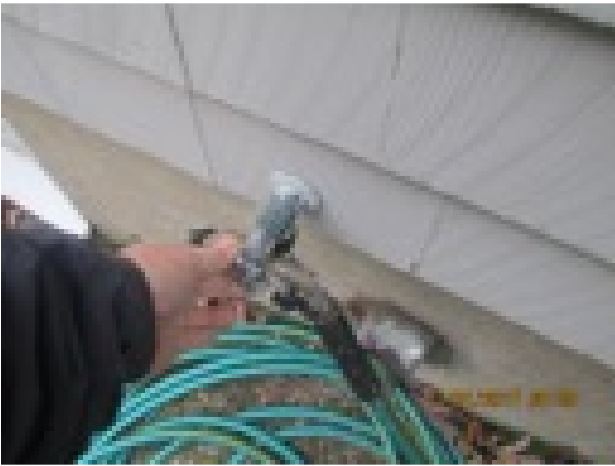
File name IMG_2186.JPG

Description: **Missing screws to faucet**

Unsatisfactory (Contractor required)

Action: Recommend consult a qualified contractor
Required: for full evaluation/repairs or replacement.

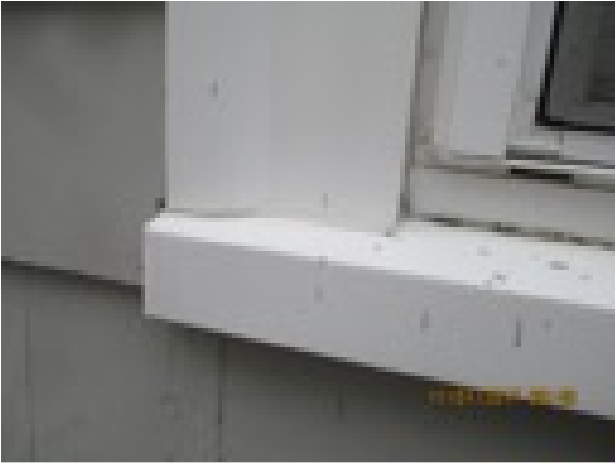
File name IMG_2195.JPG

Description: **Missing caulking to trim noted**

Unsatisfactory (Contractor required)

Action: Recommend consult a qualified contractor
Required: for full evaluation/repairs or replacement.

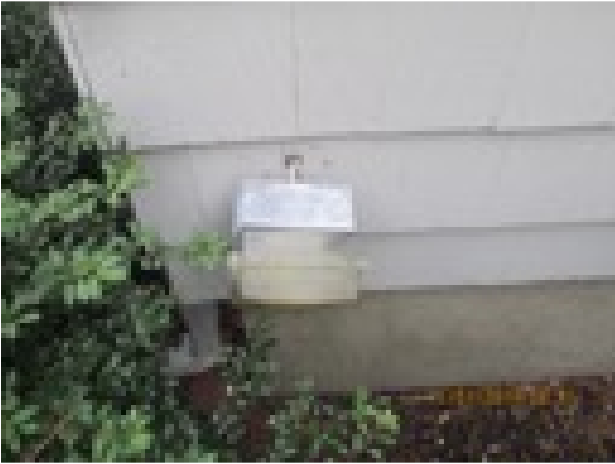
File name IMG_2197.JPG

Description: **Disconnecting outlet noted**

Unsatisfactory (Contractor required)

Action: Recommend consult a qualified contractor
Required: for full evaluation/repairs or replacement.

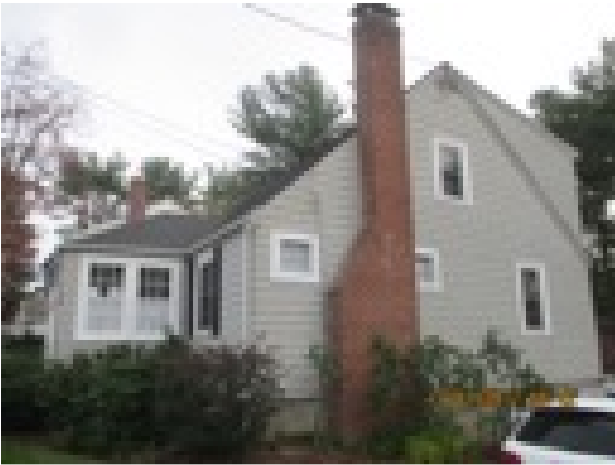
File name IMG_2203.JPG

Description: **Missing mortar to chimney noted**

Less than Satisfactory (Contractor advised)

Action: Recommend consult a qualified contractor
Required: for full evaluation/repairs or replacement.

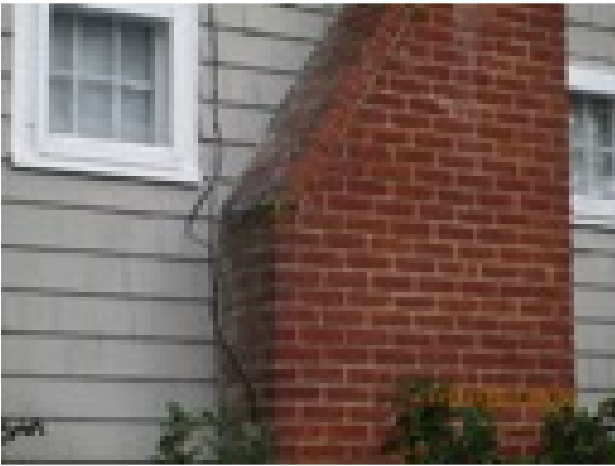
File name IMG_2205.JPG

Description: **Missing mortar to chimney noted**

Less than Satisfactory (Contractor advised)

Action: Recommend consult a qualified contractor
Required: for full evaluation/repairs or replacement.

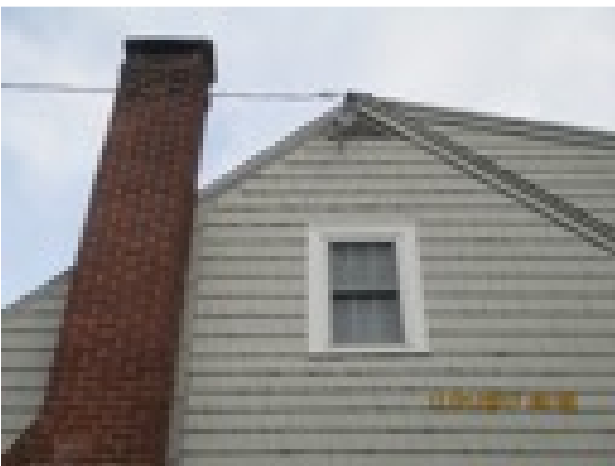
Description: **Damaged siding noted**

Less than Satisfactory (Contractor advised)

Action: Recommend consult a qualified contractor
Required: for full evaluation/repairs or replacement.

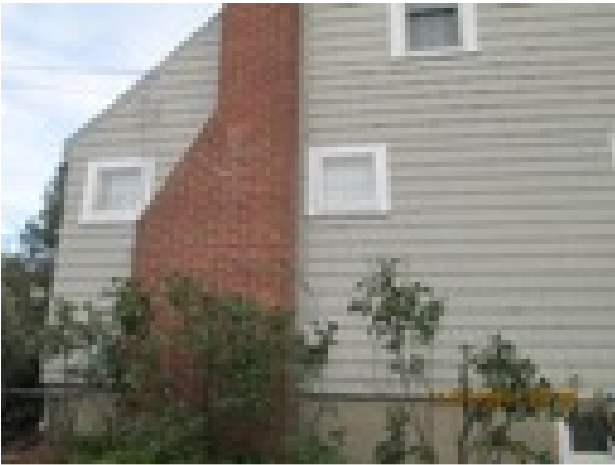
File name IMG_2207.JPG

Description: **Damaged siding noted**

Unsatisfactory (Contractor required)

Action: Recommend consult a qualified contractor
Required: for full evaluation/repairs or replacement.

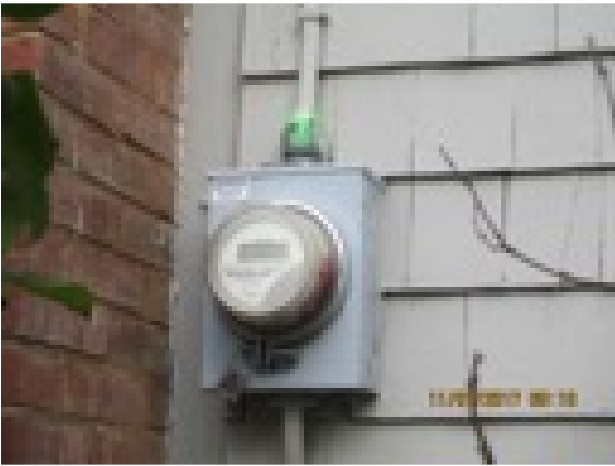
File name IMG_2211.JPG

Description: **Update/replace seal to meter**

Less than Satisfactory (Contractor advised)

Action: Recommend consult a qualified contractor
Required: for full evaluation/repairs or replacement.

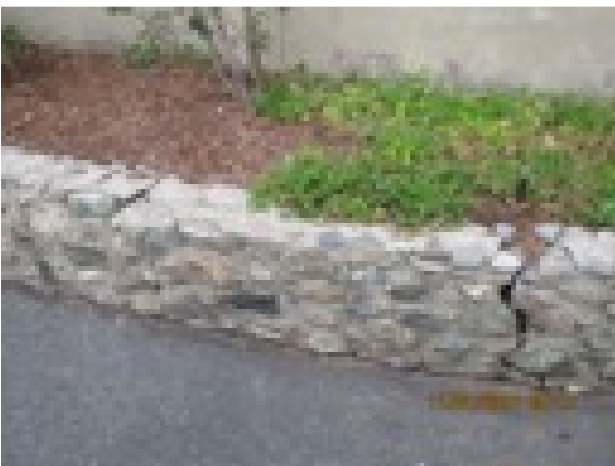
Description: **Cracked and shifting retainer wall**

Unsatisfactory (Contractor required)

Action: Recommend consult a qualified contractor
Required: for full evaluation/repairs or replacement.

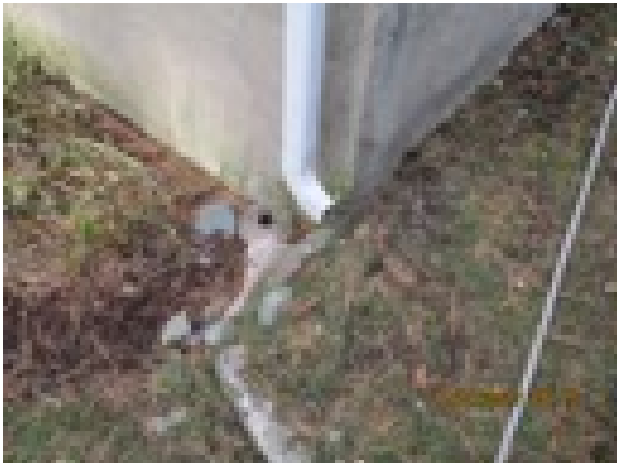
File name IMG_2215.JPG
Date of photo: 11/1/2017
Report Page: Exterior: Grade/Drainage
Description: Update grading and extend downspouts from structure
Action: Recommend consult a qualified contractor
Required: for full evaluation/repairs or replacement.

Less than Satisfactory (Contractor advised)

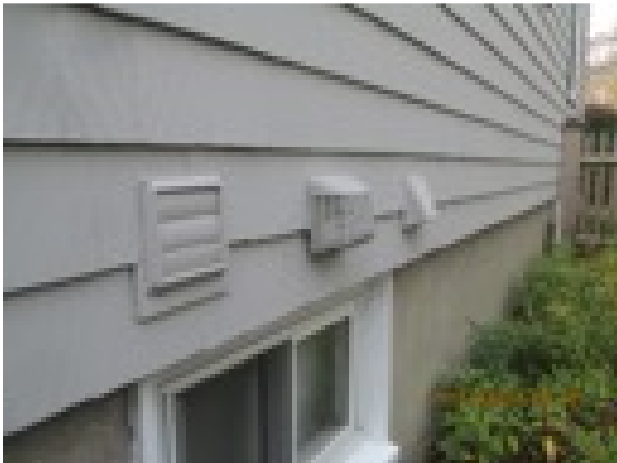
File name IMG_2216.JPG
Date of photo: 11/1/2017
Report Page: Exterior
Description: multiple vents noted, clean and evaluate
Action: Recommend consult a qualified contractor
Required: for full evaluation/repairs or replacement.

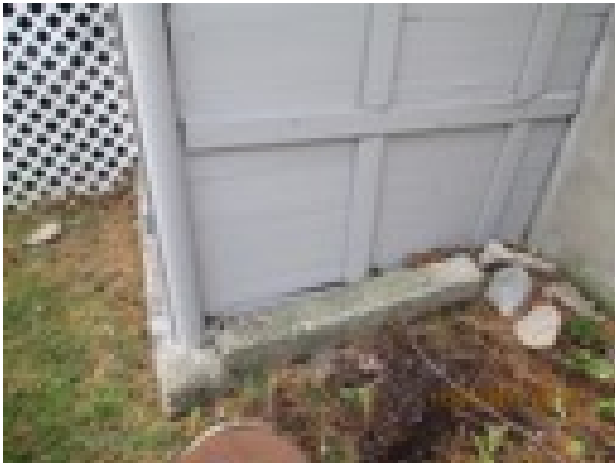
File name IMG_2221.JPG

Description: **Substandard repairs noted to porch**

Action: Recommend consult a qualified contractor
Required: for full evaluation/repairs or replacement.

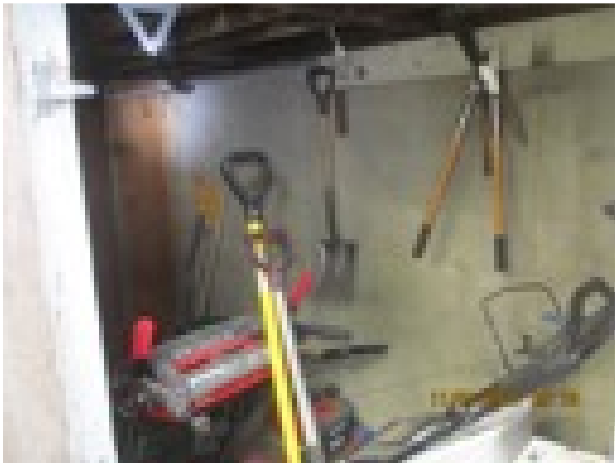
File name IMG_2222.JPG

Description: **Storage noted**

Action: ** Storage/clutter condition/adverse
Required: situations limiting safe access, remediate/
remove storage /re-inspect**

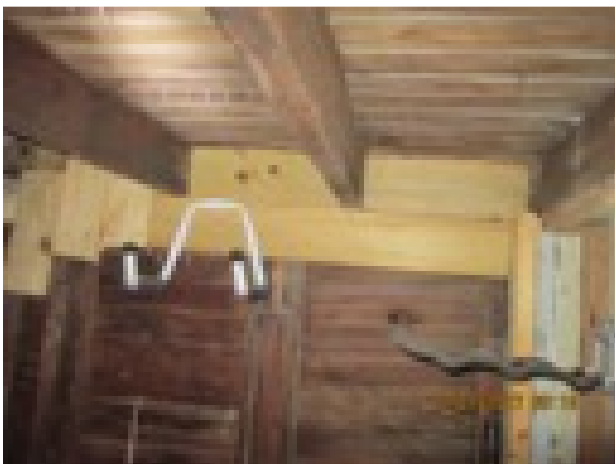
Description: **Substandard repairs noted to porch**

Less than Satisfactory (Contractor advised)

Action: Repairs noted, Obtain any and all
Required: statements, documents from all owner(s)
/Town Officials/Permits/Contractor(s) who
performs repairs and any and all
warrantees/Guarantees in writing.

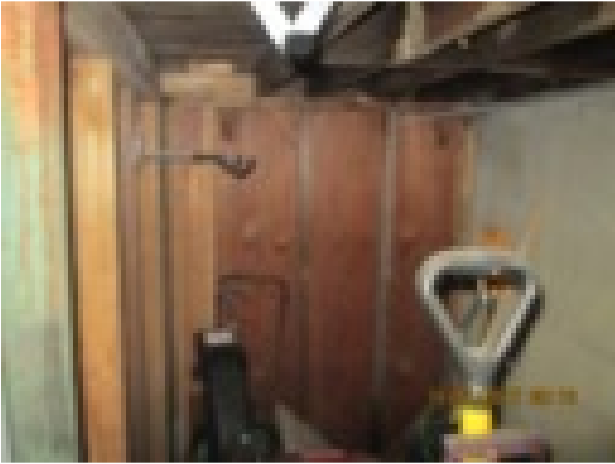
File name IMG_2229.JPG

Description: **Storage noted**

Action: ** Storage/clutter condition/adverse
Required: situations limiting safe access, remediate/
remove storage /re-inspect**

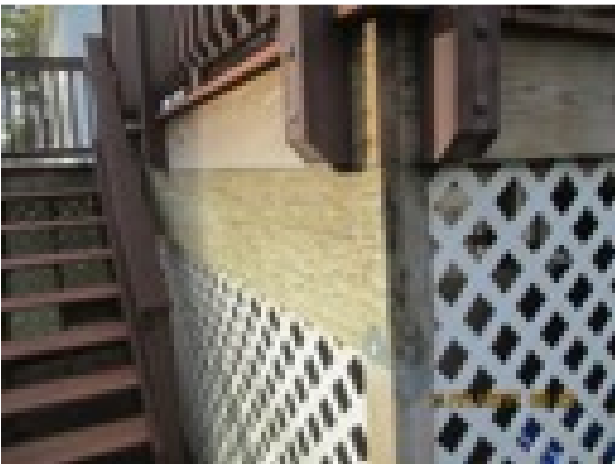
Description: **delamination to beam is subject to
replacement**

Less than Satisfactory (Contractor advised)

Action: Recommend consult a qualified contractor
Required: for full evaluation/repairs or replacement.

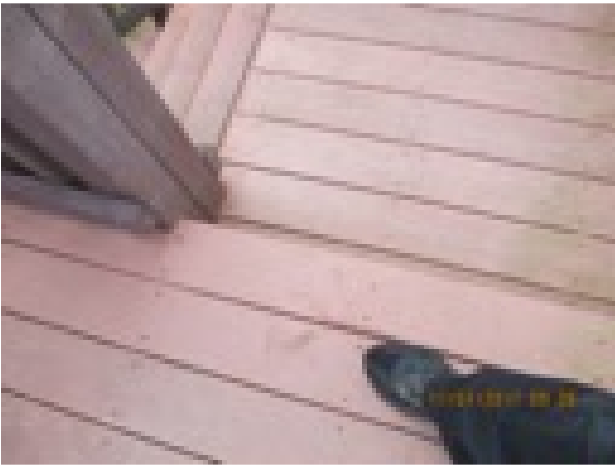
File name IMG_2234.JPG

Description: **Raised decking is a trip hazard**

Less than Satisfactory (Contractor advised)

Action: Recommend consult a qualified contractor
Required: for full evaluation/repairs or replacement.

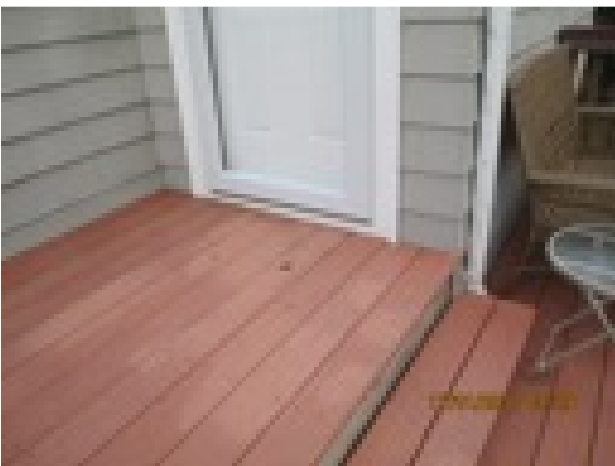
Description: **Improper deck height to storm door**

Less than Satisfactory (Contractor advised)

Action: Recommend consult a qualified contractor
Required: for full evaluation/repairs or replacement.

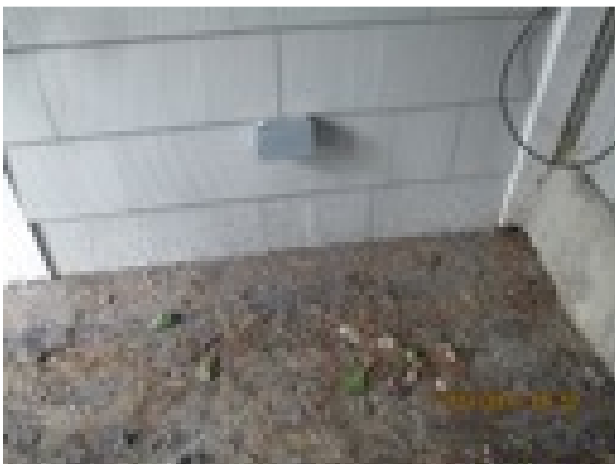
Description: **Sidewall to earth contact with gaps and holes for rodents noted.**

Less than Satisfactory (Contractor advised)

Action: Recommend consult a qualified contractor
Required: for full evaluation/repairs or replacement.

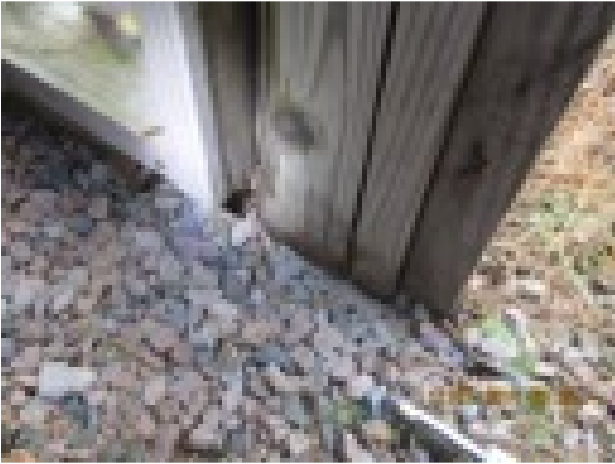
File name IMG_2249.JPG

Description: Rust and corroded metal support brackets

Less than Satisfactory (Contractor advised)

Action: Recommend consult a qualified contractor
Required: for full evaluation/repairs or replacement.

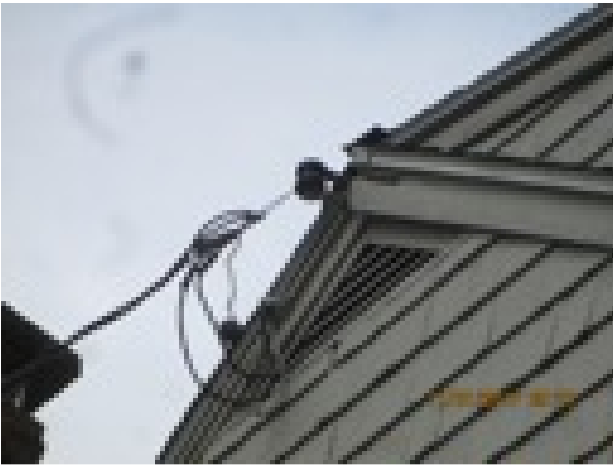
File name IMG_2251.JPG

Description: **Damaged trim board noted**

Unsatisfactory (Contractor required)

Action: Recommend consult a qualified contractor
Required: for full evaluation/repairs or replacement.

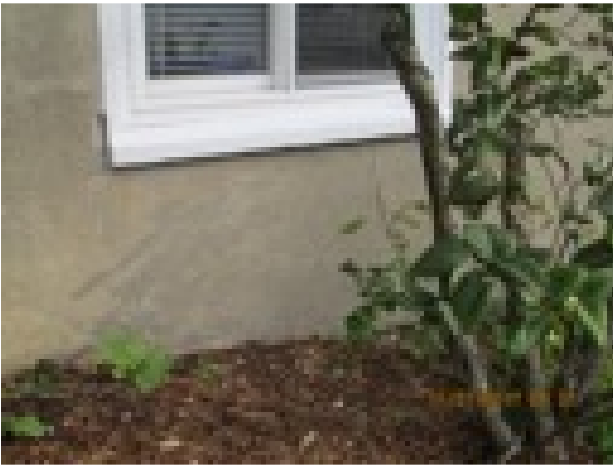
File name IMG_2252.JPG

Description: **Cracks in foundation noted**

Unsatisfactory (Contractor required)

Action: Recommend consult a qualified contractor
Required: for full evaluation/repairs or replacement.

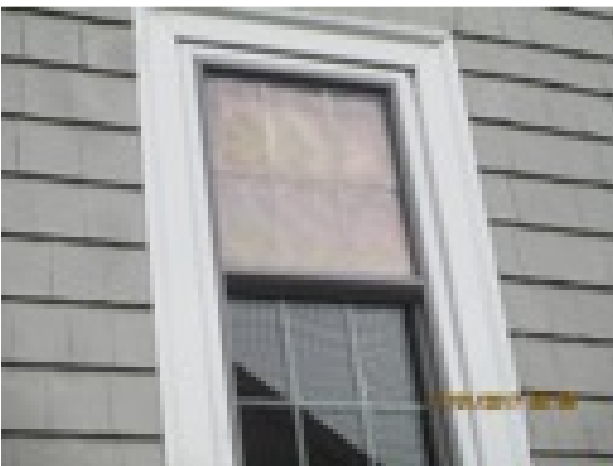
Description: **Broken thermal seals noted is subject to replacement**

Unsatisfactory (Contractor required)

Action: Recommend consult a qualified contractor
Required: for full evaluation/repairs or replacement.

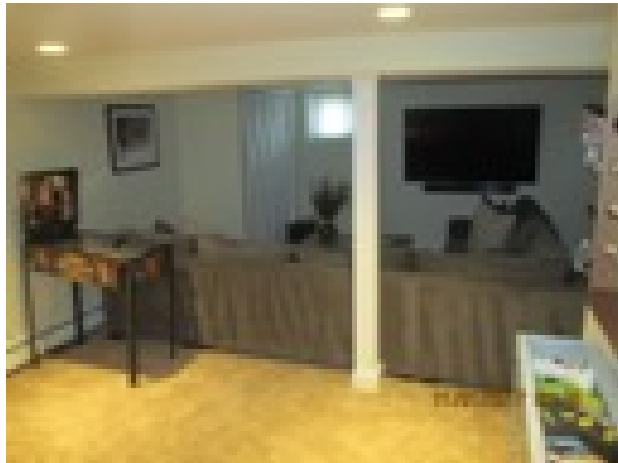
File name IMG_2260.JPG
Date of photo: 11/1/2017
Report Page: Basement
Description: Finished basement noted, structure composites not viewed
Action: Repairs noted, Obtain any and all statements, documents from all owner(s) /Town Officials/Permits/Contractor(s) who performs repairs and any and all warranties/Guarantees in writing.
Required:
Address of Property: 10 Shore Dr Marshfield Ma

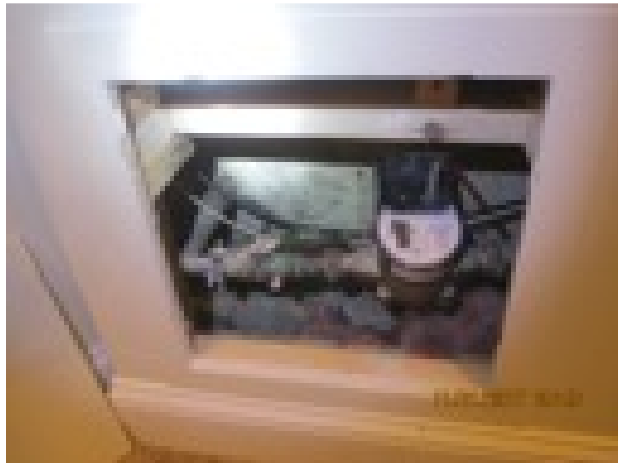
Less than Satisfactory (Contractor advised)

File name IMG_2261.JPG
Date of photo: 11/1/2017
Report Page: Plumbing System
Description: Older water main noted is subject to replacement
Action: Recommend consult a qualified contractor for full evaluation/repairs or replacement.
Required:
Address of Property: 10 Shore Dr Marshfield Ma

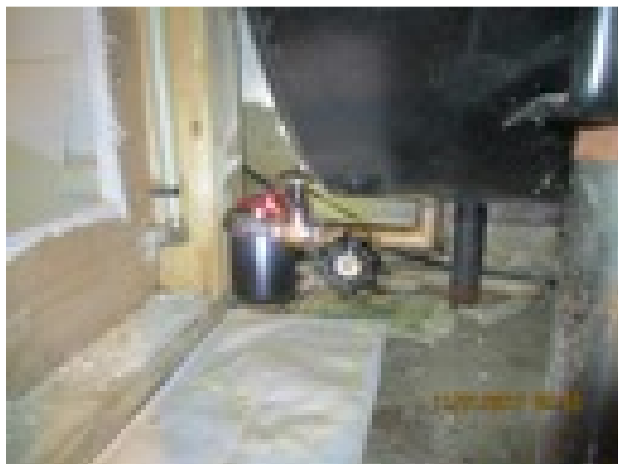
Less than Satisfactory (Contractor advised)

File name IMG_2267.JPG
Date of photo: 11/1/2017
Report Page: Heating System
Description: Small stains of oil noted to floor and oil lines noted
Action: Recommend consult a qualified contractor for full evaluation/repairs or replacement.
Required:
Address of Property: 10 Shore Dr Marshfield Ma

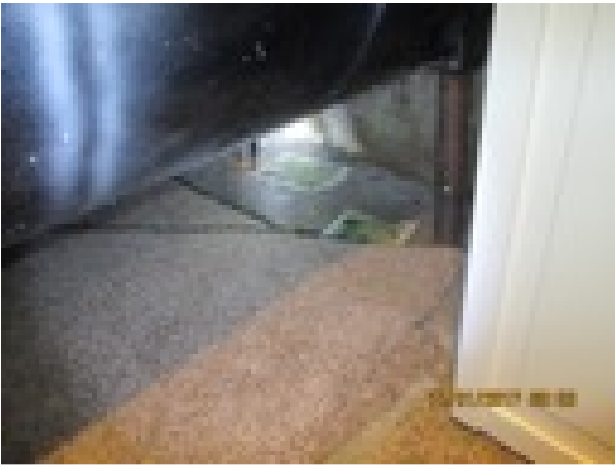
File name IMG_2271.JPG

Description: **Rodent traps noted to basement**

Less than Satisfactory (Contractor advised)

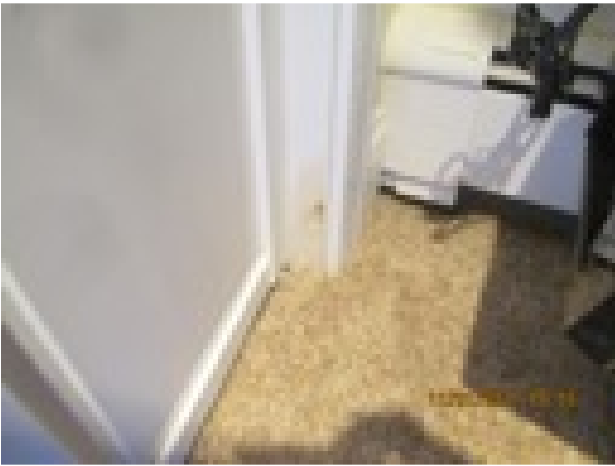
File name IMG_2272.JPG

Description: **Water damage noted to trim base**

Unsatisfactory (Contractor required)

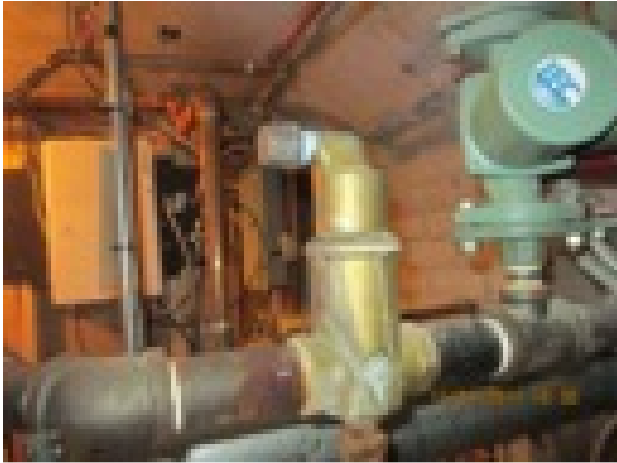
Unsatisfactory (Contractor required)

File name IMG_2326.JPG
Date of photo: 11/1/2017
Report Page: Heating System
Description: Spirovent improperly capped

Action: Recommend consult a qualified contractor
Required: for full evaluation/repairs or replacement.

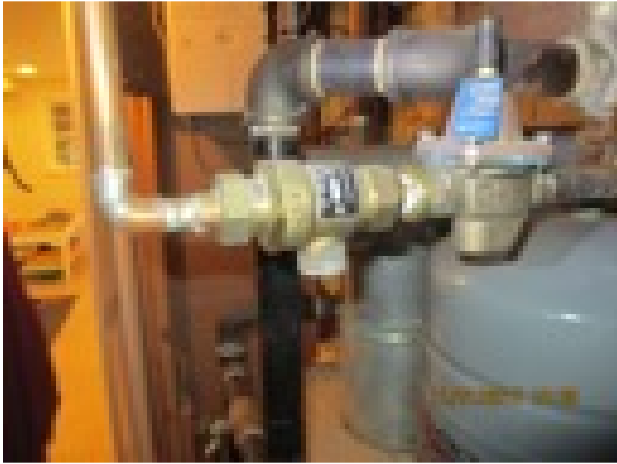
Unsatisfactory (Contractor required)

File name IMG_2327.JPG
Date of photo: 11/1/2017
Report Page: Plumbing System
Description: Missing relief tube noted

Action: Recommend consult a qualified contractor
Required: for full evaluation/repairs or replacement.

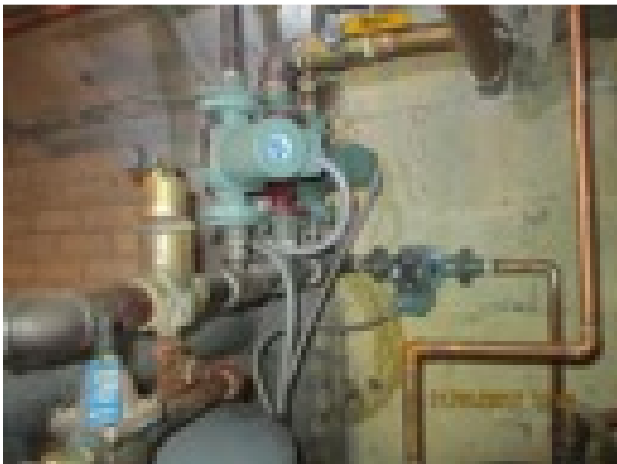
Less than Satisfactory (Contractor advised)

File name IMG_2328.JPG
Date of photo: 11/1/2017
Report Page: Heating System
Description: Prior leaks noted to pipes and heating

Action: Recommend consult a qualified contractor
Required: for full evaluation/repairs or replacement.
