*CLAYTON HOME INSPECTION, INC.*

Home Inspection Report for:  
John Smith

10 Shore Dr Marshfield Ma

# Wood Destroying Insect Inspection Report

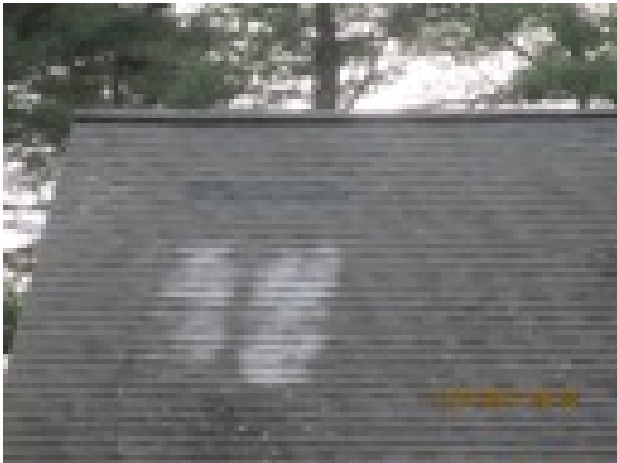
File name IMG\_2169.JPG

Less than Satisfactory (Contractor advised)

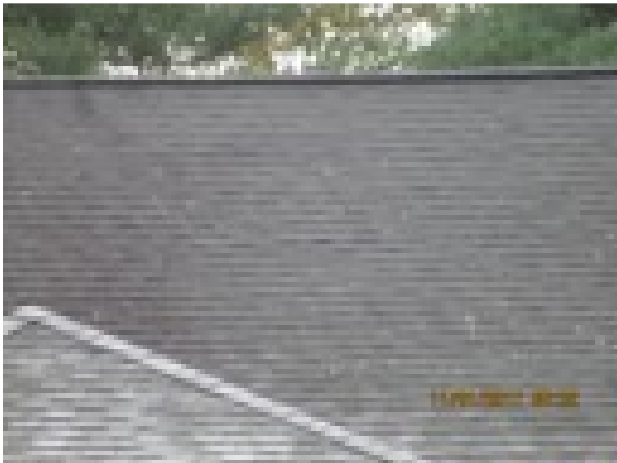
File name IMG\_2170.JPG

Less than Satisfactory (Contractor advised)

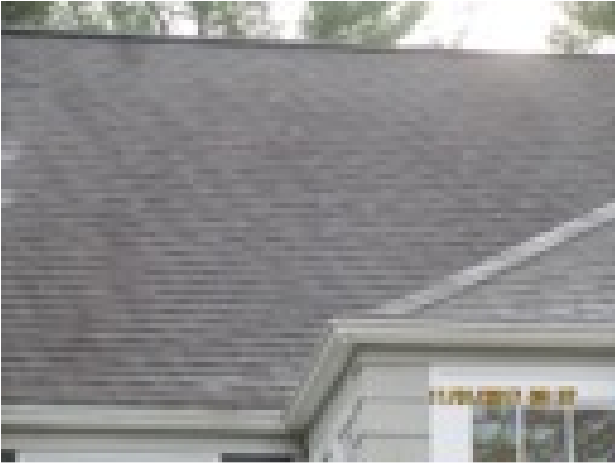
File name IMG\_2172.JPG

Less than Satisfactory (Contractor advised)

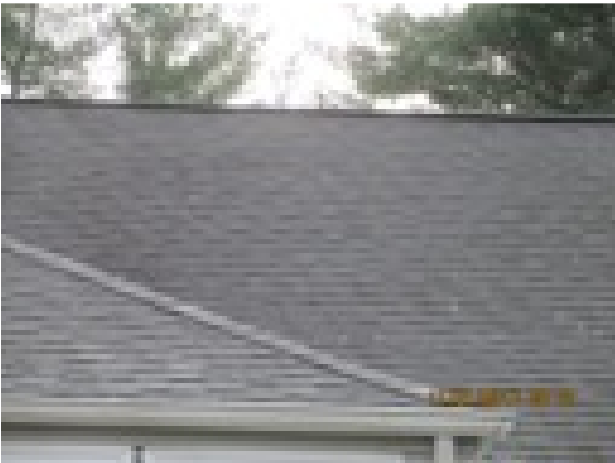
File name IMG\_2173.JPG

Less than Satisfactory (Contractor advised)

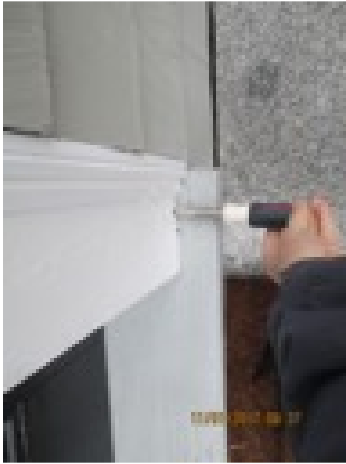
File name IMG\_2176.JPG

Unsatisfactory (Contractor required)

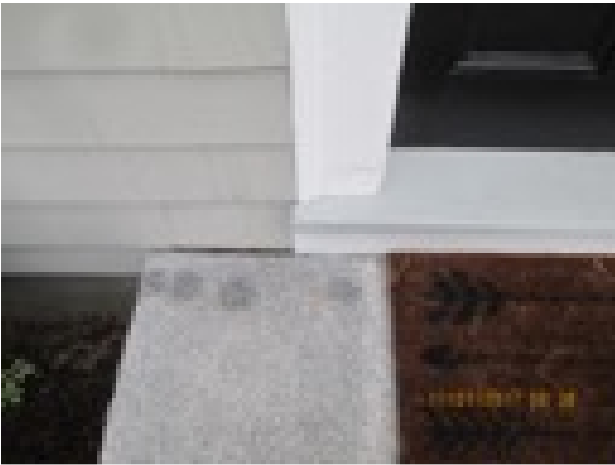
File name IMG\_2179.JPG

Less than Satisfactory (Contractor advised)

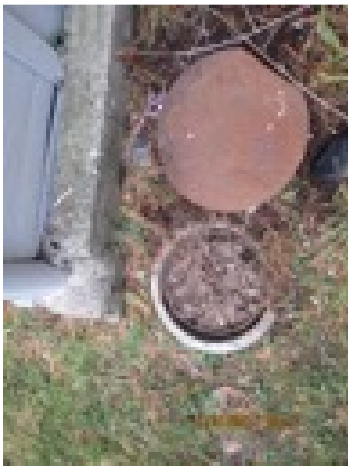
Less than Satisfactory (Contractor advised)

File name IMG\_2218.JPG  
Date of photo: 11/1/2017  
Report Page: Exterior  
Description: Abandoned garbage bin noted, recommended remove as needed  
Action: Recommend consult a qualified contractor  
Required: for full evaluation/repairs or replacement.

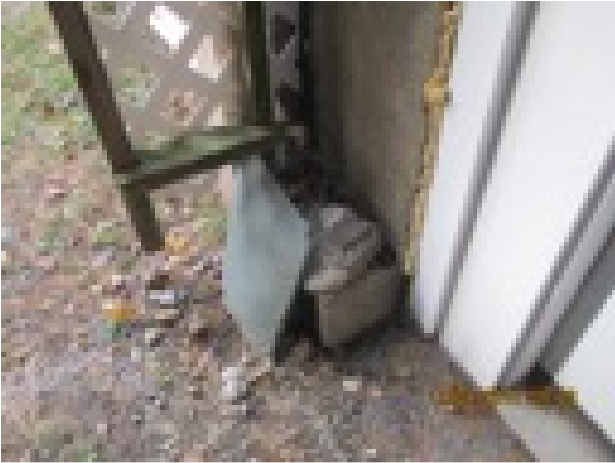
File name IMG\_2248.JPG

Less than Satisfactory (Contractor advised)

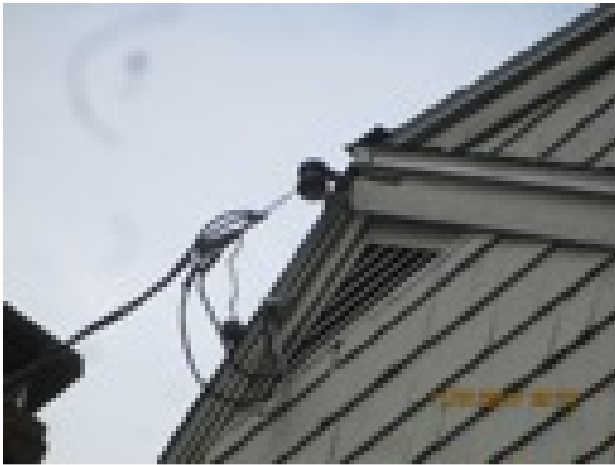
File name IMG\_2251.JPG

Unsatisfactory (Contractor required)

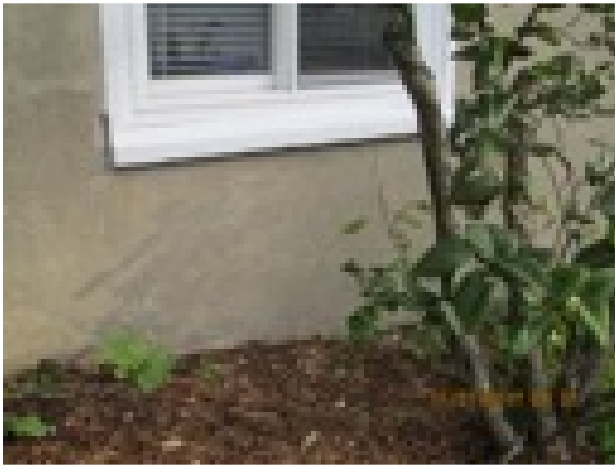
File name IMG\_2252.JPG

Unsatisfactory (Contractor required)

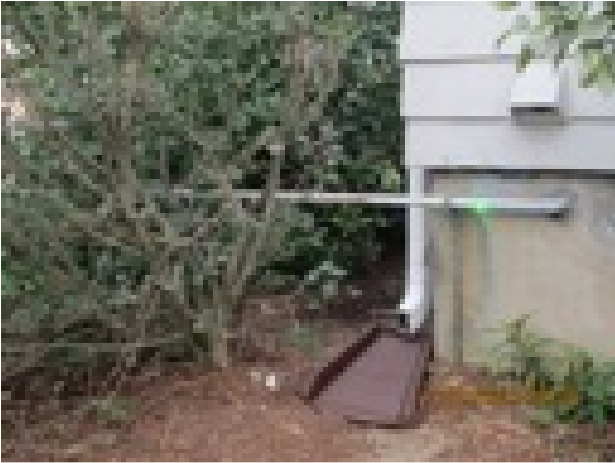
File name IMG\_2253.JPG

Unsatisfactory (Contractor required)

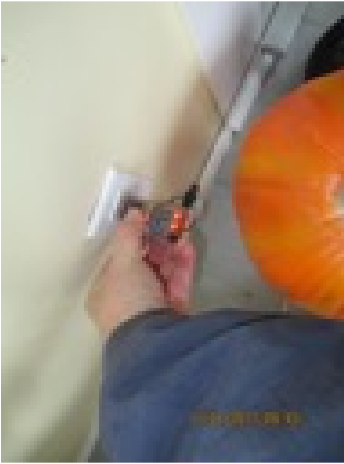
File name IMG\_2257.JPG

Less than Satisfactory (Contractor advised)

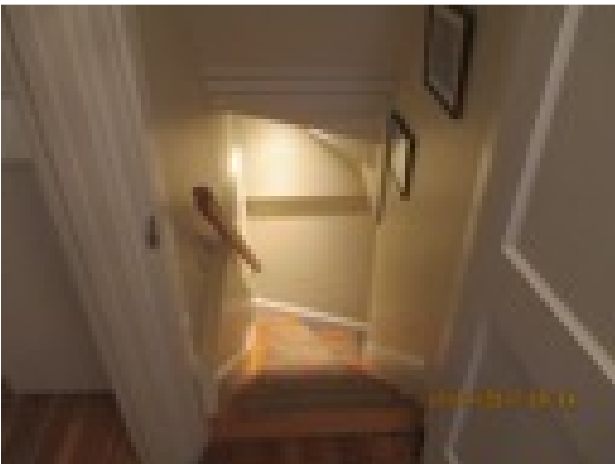
File name IMG\_2258.JPG

Unsatisfactory (Contractor required)

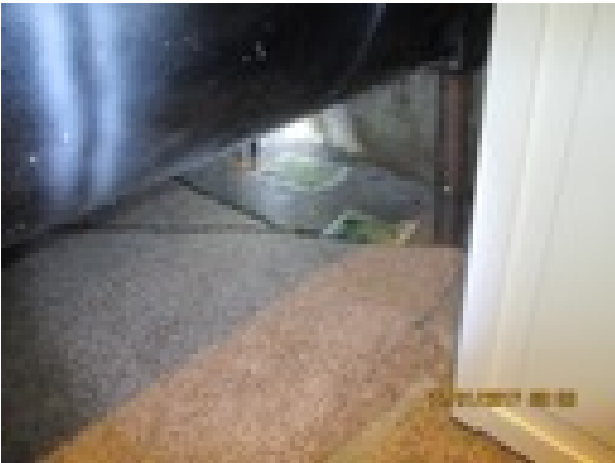
File name IMG\_2271.JPG

Less than Satisfactory (Contractor advised)

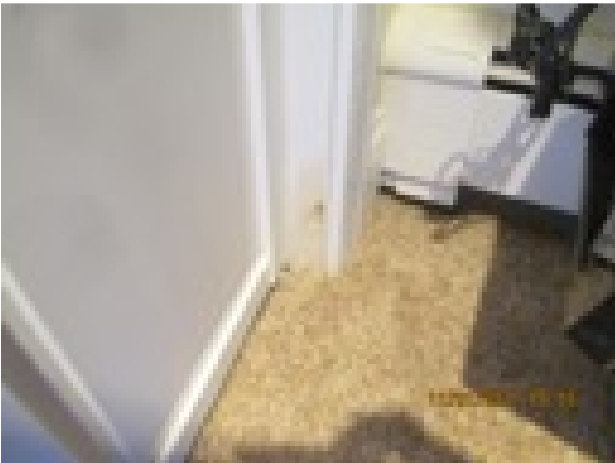
File name IMG\_2272.JPG

Unsatisfactory (Contractor required)

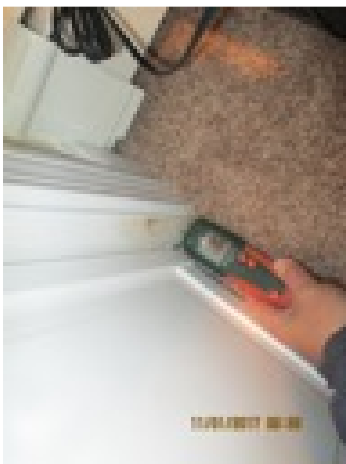
Description: **Elevated moisture levels noted**

Action: Recommend consult a qualified contractor  
Required: for full evaluation/repairs or replacement.

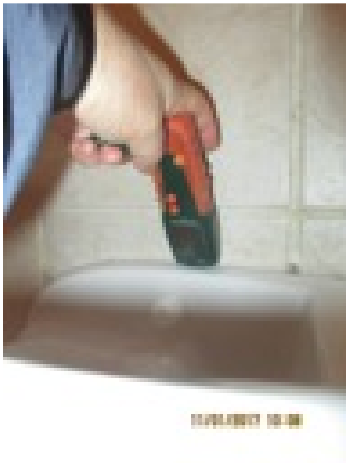
File name IMG\_2292.JPG  
Date of photo: 11/1/2017  
Report Page: Plumbing System  
Description: Elevated levels of moisture noted  
Action: Recommend consult a qualified contractor  
Required: for full evaluation/repairs or replacement.

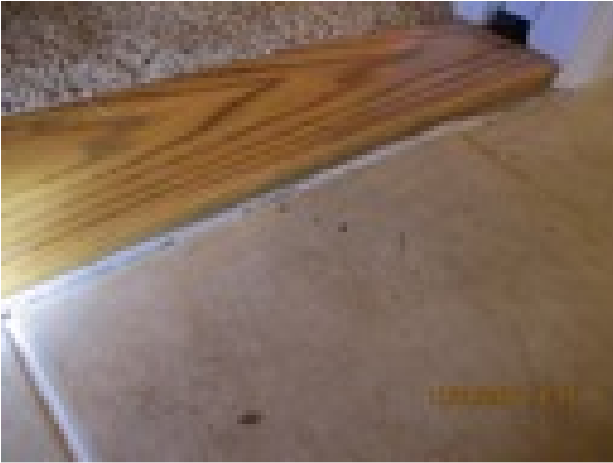
File name IMG\_2304.JPG

Not Accessible

Action: \*\* Storage/clutter condition/adverse  
Required: situations limiting safe access, remediate/  
remove storage /re-inspect\*\*

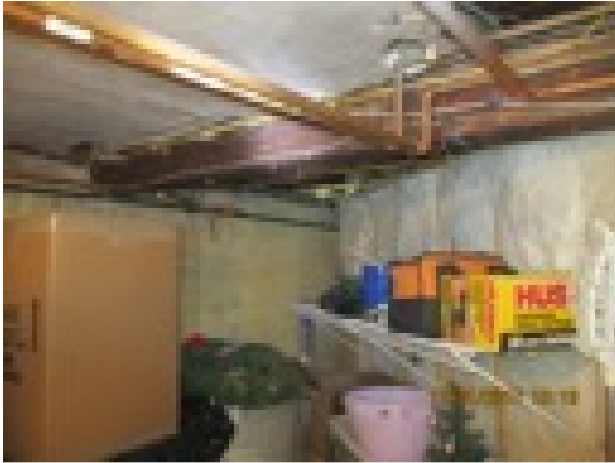
File name IMG\_2309.JPG

Unsatisfactory (Contractor required)

Action: Recommend consult a qualified contractor  
Required: for full evaluation/repairs or replacement.

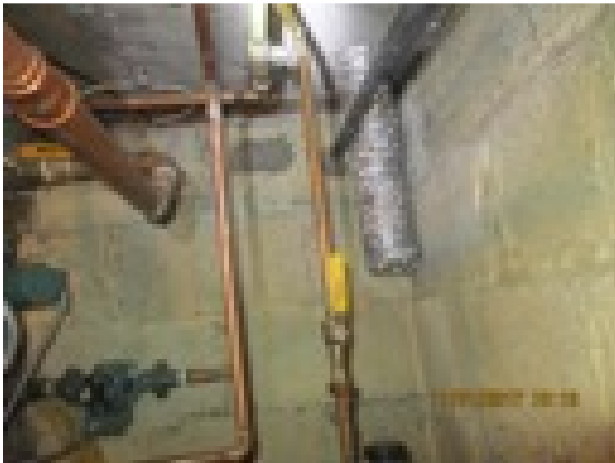
File name IMG\_2310.JPG

Unsatisfactory (Contractor required)

Action: Recommend consult a qualified contractor  
Required: for full evaluation/repairs or replacement.

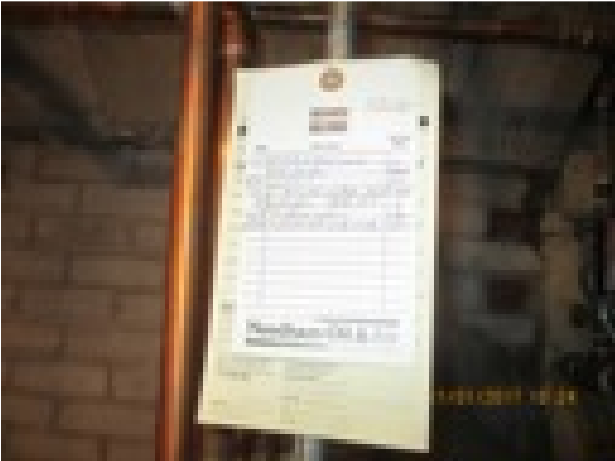
File name IMG\_2316.JPG  
Date of photo: 11/1/2017  
Report Page: Heating System  
Description: **Heating serviced 12/9/2016, requires service and repairs and purging ASAP.**

Action: Recommend consult a qualified contractor  
Required: for full evaluation/repairs or replacement.

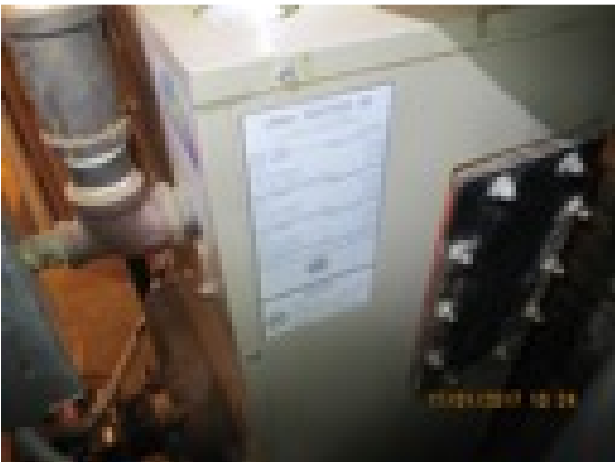
File name IMG\_2317.JPG  
Date of photo: 11/1/2017  
Report Page: Heating System  
Description: **Serial date 2004 likely**

Action: Recommend consult a qualified contractor  
Required: for full evaluation/repairs or replacement.

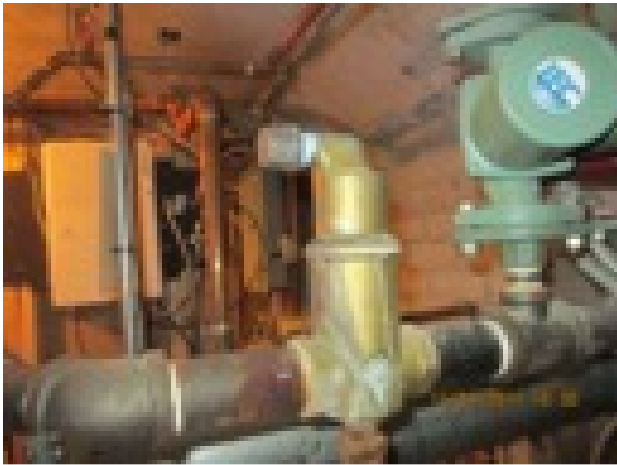
File name IMG\_2326.JPG

Unsatisfactory (Contractor required)

Description: Spirovent improperly capped

Action: Recommend consult a qualified contractor  
Required: for full evaluation/repairs or replacement.

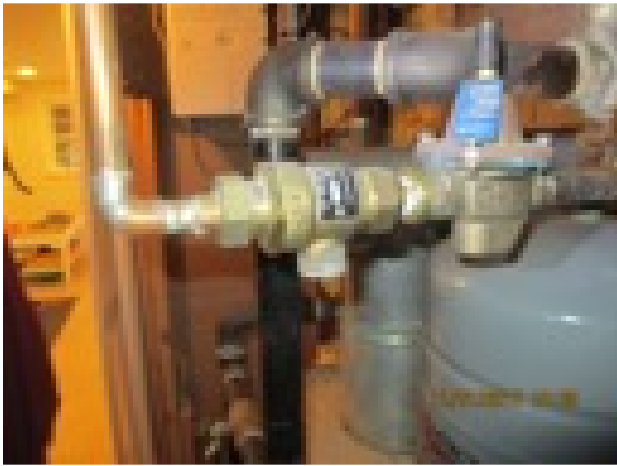
File name IMG\_2327.JPG

Unsatisfactory (Contractor required)

Description: Missing relief tube noted

Action: Recommend consult a qualified contractor  
Required: for full evaluation/repairs or replacement.

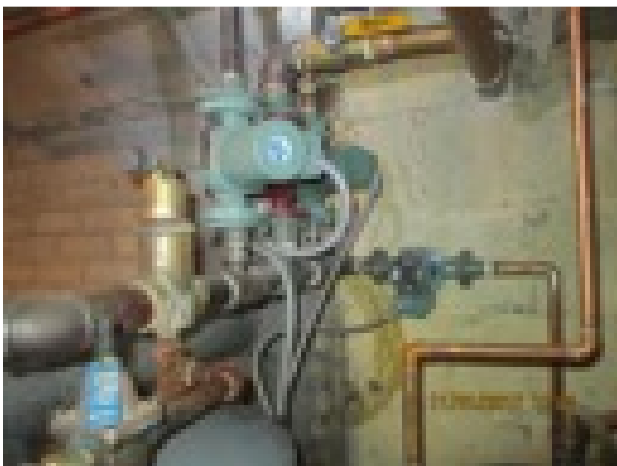
File name IMG\_2328.JPG

Less than Satisfactory (Contractor advised)

Description: Prior leaks noted to pipes and heating

Action: Recommend consult a qualified contractor  
Required: for full evaluation/repairs or replacement.

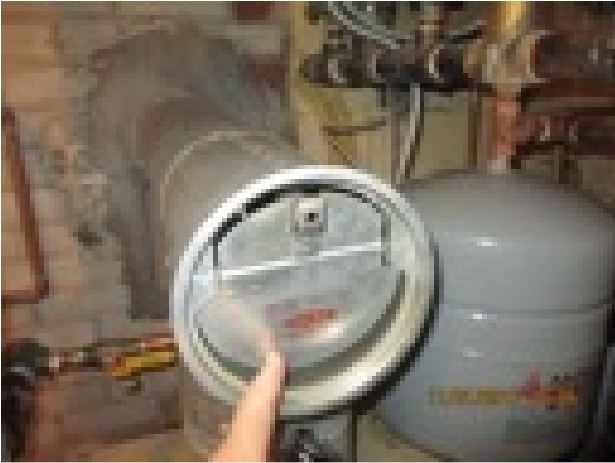
File name IMG\_2332.JPG

Description: **chimney flue noted to interior of chimney**

Action: Recommend consult a qualified contractor  
Required: for full evaluation/repairs or replacement.

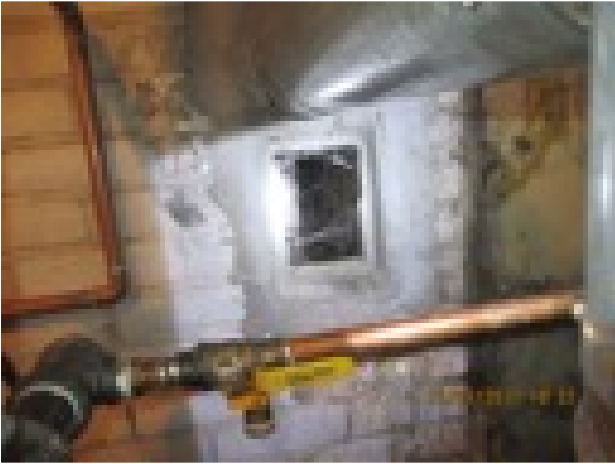
File name IMG\_2340.JPG

Unsatisfactory (Contractor required)

Description: **Evidence of water penetration noted**

Action: Recommend consult a qualified contractor  
Required: for full evaluation/repairs or replacement.

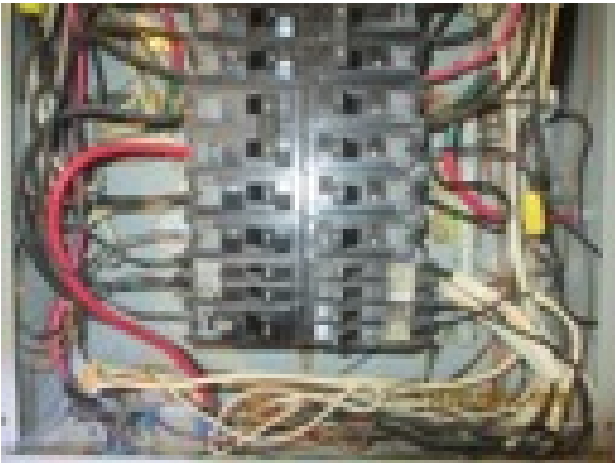
File name IMG\_2343.JPG  
Date of photo: 11/1/2017  
Report Page: Electric System  
Description: Evidence of water penetration noted

Action: Recommend consult a qualified contractor  
Required: for full evaluation/repairs or replacement.

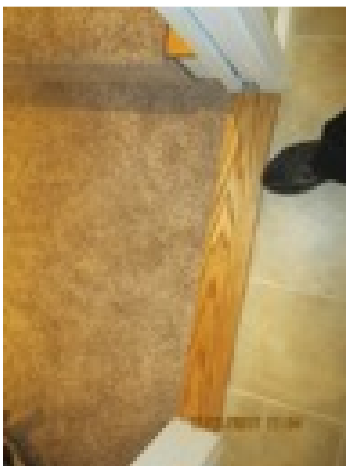
File name IMG\_2354.JPG  
Date of photo: 11/1/2017  
Report Page: Basement  
Description: Unleveled, dips, settled floors and Raised threshold is a trip hazard

Action: Recommend consult a qualified contractor  
Required: for full evaluation/repairs or replacement.

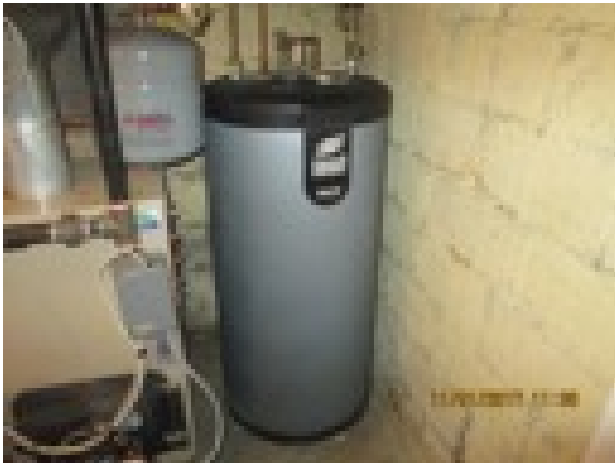
File name IMG\_2356.JPG

Less than Satisfactory (Contractor advised)

Description: Pitting to supply pipes noted

Action: Recommend consult a qualified contractor  
Required: for full evaluation/repairs or replacement.

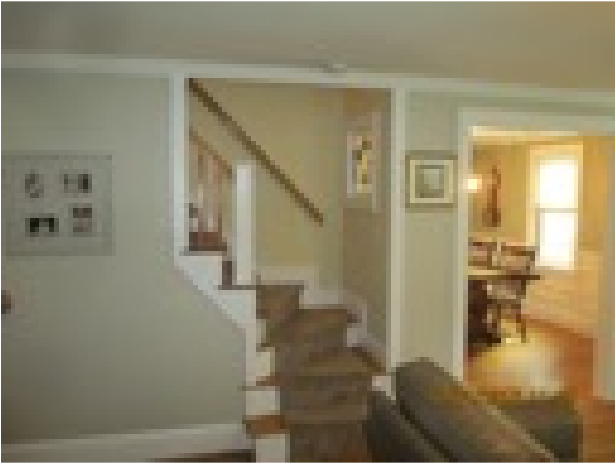
File name IMG\_2361.JPG

Unsatisfactory (Contractor required)

Description: Repair open ended handrails noted

Action: Recommend consult a qualified contractor  
Required: for full evaluation/repairs or replacement.

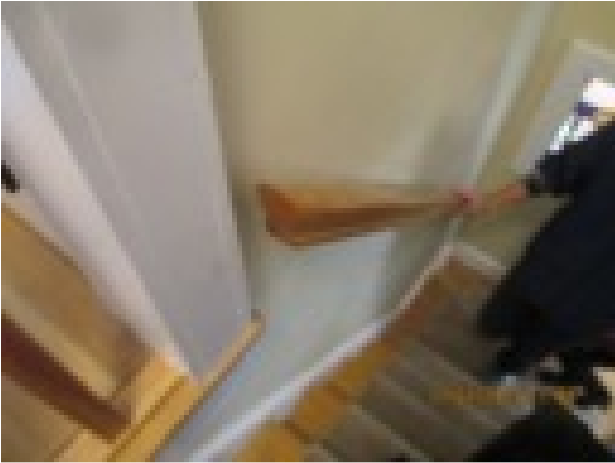
File name IMG\_2366.JPG

Less than Satisfactory (Contractor advised)

Description: **Raised floor is a potential trip hazard noted**

Action: Recommend consult a qualified contractor  
Required: for full evaluation/repairs or replacement.

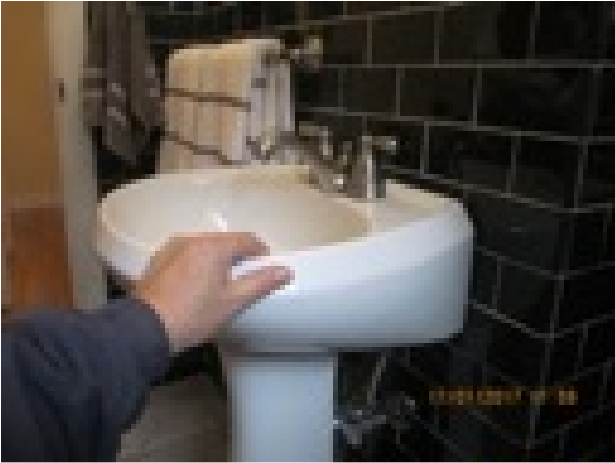
File name IMG\_2371.JPG

Less than Satisfactory (Contractor advised)

Description: **Loose sink noted**

Action: Recommend consult a qualified contractor  
Required: for full evaluation/repairs or replacement.

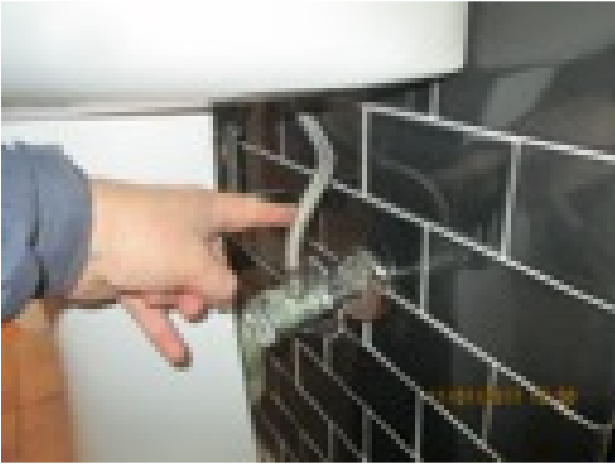
File name IMG\_2372.JPG

Less than Satisfactory (Contractor advised)

Description: **Replace all flex hoses to prevent leakage every 10 years**

Action: Recommend consult a qualified contractor  
Required: for full evaluation/repairs or replacement.

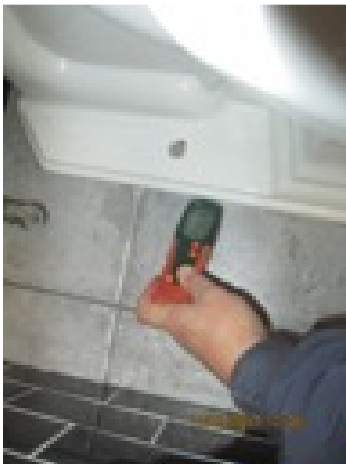
File name IMG\_2373.JPG

Unsatisfactory (Contractor required)

Description: **Elevated levels of moisture noted to toilet base**

Action: Recommend consult a qualified contractor  
Required: for full evaluation/repairs or replacement.

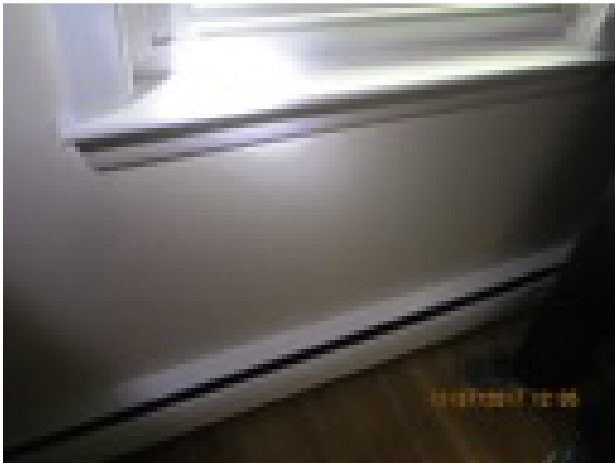
File name IMG\_2381.JPG

Less than Satisfactory (Contractor advised)

Description: **Popping nails noted**

Action: Recommend consult a qualified contractor  
Required: for full evaluation/repairs or replacement.

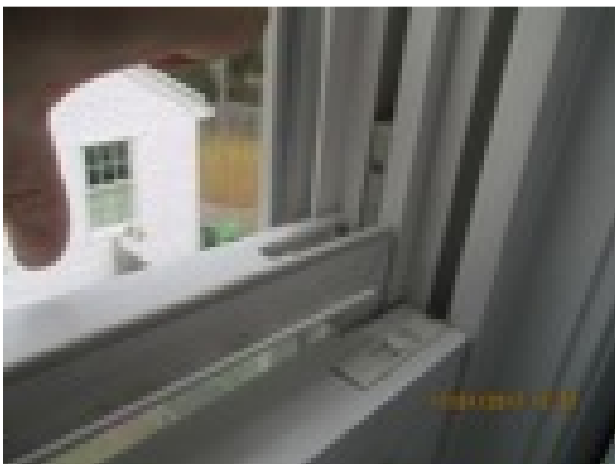
File name IMG\_2384.JPG

Unsatisfactory (Contractor required)

Description: **Broken/disconnected springs to window noted are a safety issue.**

Action: Recommend consult a qualified contractor  
Required: for full evaluation/repairs or replacement.

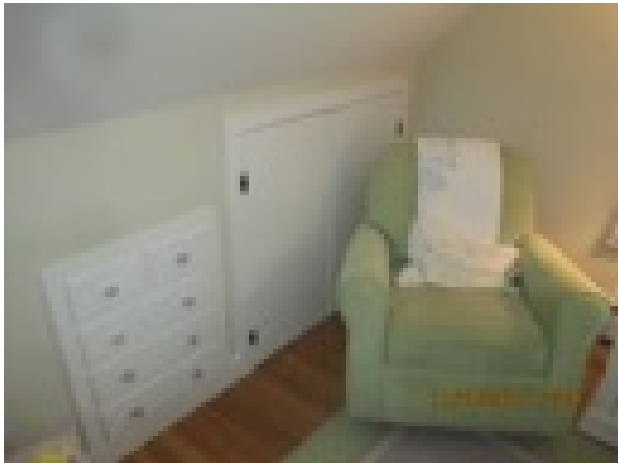
File name IMG\_2389.JPG

Less than Satisfactory (Contractor advised)

Description: **Water stains noted to interior of closet/burrows noted**

Action: Recommend consult a qualified contractor  
Required: for full evaluation/repairs or replacement.

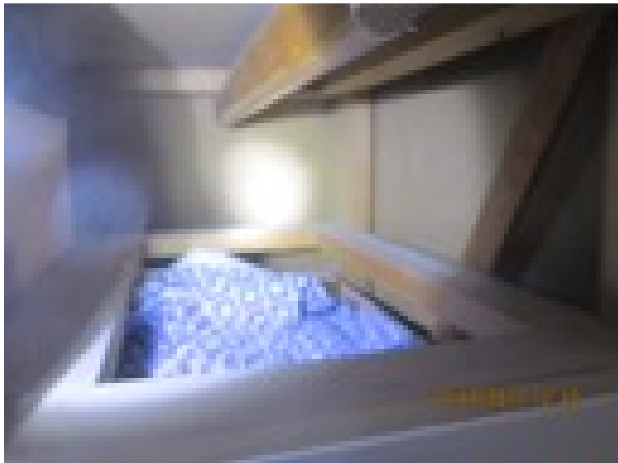
File name IMG\_2394.JPG

Less than Satisfactory (Contractor advised)

Description: **Safety issue noted**

Action: Recommend consult a qualified contractor  
Required: for full evaluation/repairs or replacement.

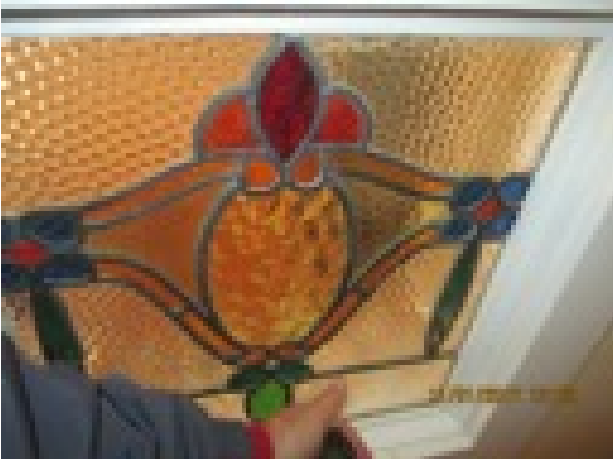
File name IMG\_2401.JPG

Less than Satisfactory (Contractor advised)

Action: Recommend consult a qualified contractor  
Required: for full evaluation/repairs or replacement.

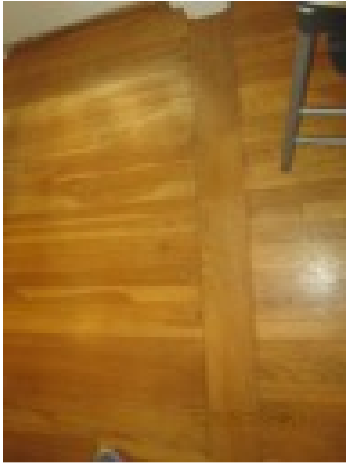
File name IMG\_2408.JPG

Less than Satisfactory (Contractor advised)

Description: **Wall removal evidence noted**

Action: Repairs noted, Obtain any and all  
Required: statements, documents from all owner(s)  
/Town Officials/Permits/Contractor(s) who  
performs repairs and any and all  
warrantees/Guarantees in writing.

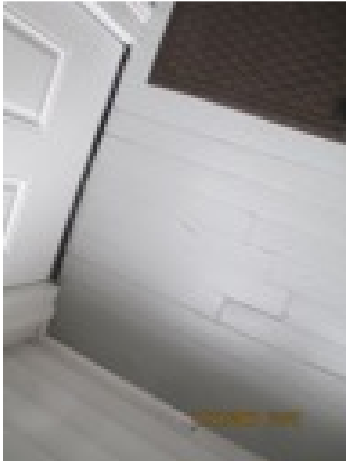
File name IMG\_2410.JPG

Less than Satisfactory (Contractor advised)

Description: **Patched porch flooring noted**

Action: Repairs noted, Obtain any and all  
Required: statements, documents from all owner(s)  
/Town Officials/Permits/Contractor(s) who  
performs repairs and any and all  
warrantees/Guarantees in writing.

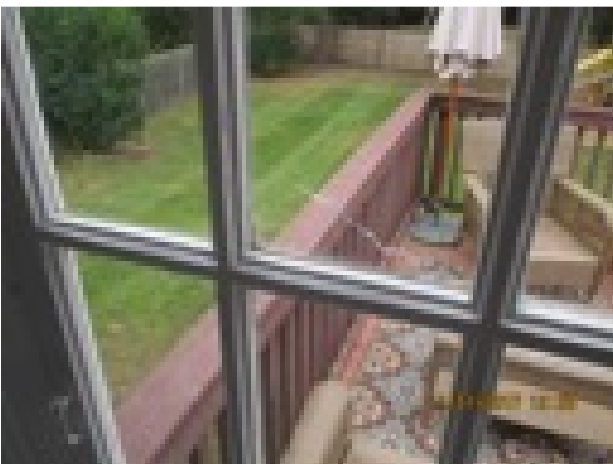
File name IMG\_2412.JPG

Unsatisfactory (Contractor required)

Description: **Broken window pane requires replacement**

Action: Recommend consult a qualified contractor  
Required: for full evaluation/repairs or replacement.

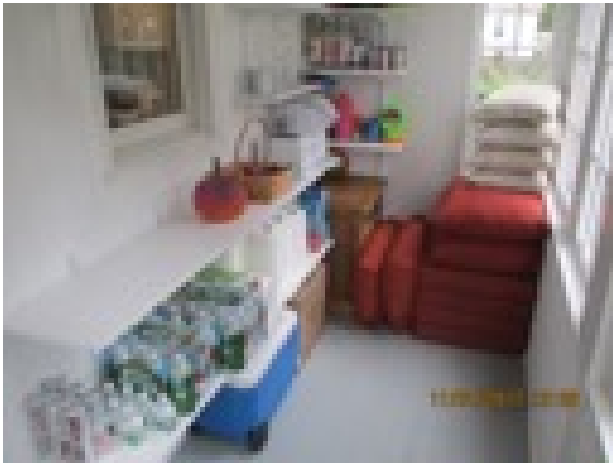
File name IMG\_2416.JPG

Not Applicable

Action: Obtain any and all statements, documents  
Required: from all owner(s)/Town  
Officials/Permits/Contractor(s) who performs  
repairs and any and all  
warrantees/Guarantees in writing.

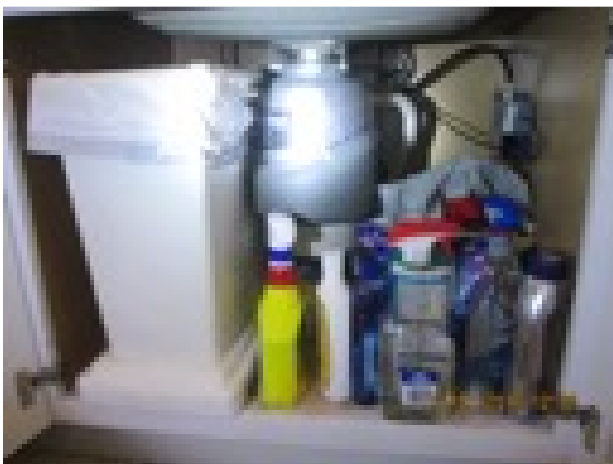
Less than Satisfactory (Contractor advised)

Description: **Gunk noted**

Action: Recommend consult a qualified contractor  
Required: for full evaluation/repairs or replacement.

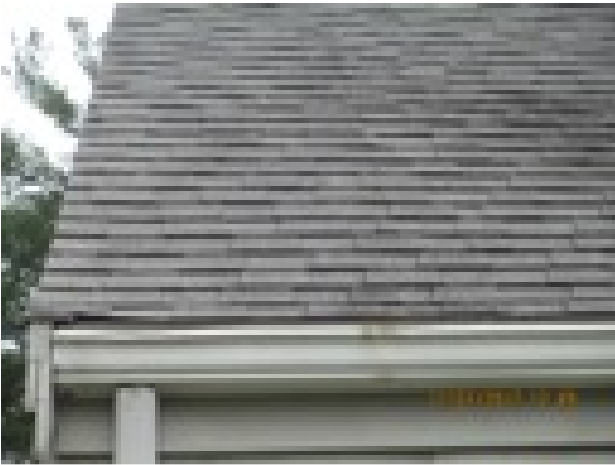
File name IMG\_2443.JPG

Less than Satisfactory (Contractor advised)

Description: **Patched roof and damaged shingles noted**

Action: Recommend consult a qualified contractor  
Required: for full evaluation/repairs or replacement.
