CLAYTON HOME INSPECTION, INC.

**Home Inspection Report for:
John Smith**

10 Shore Dr Marshfield Ma

Monday, March 11, 2019

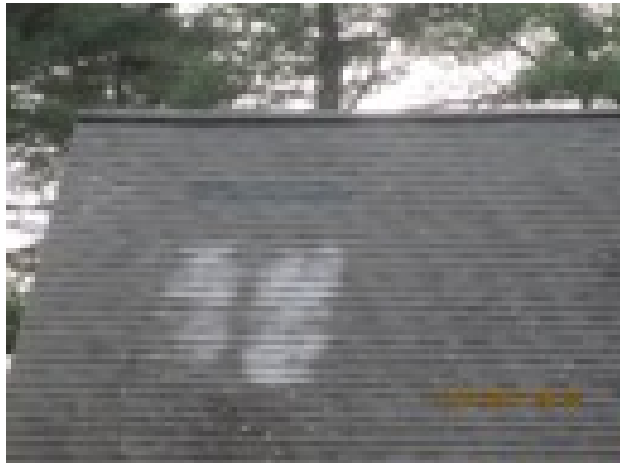
File name IMG_2168.JPG

Less than Satisfactory (Contractor advised)

Description: Repairs on roof and original install was substandard

Action: Recommend consult a qualified contractor
Required: for full evaluation/repairs or replacement.

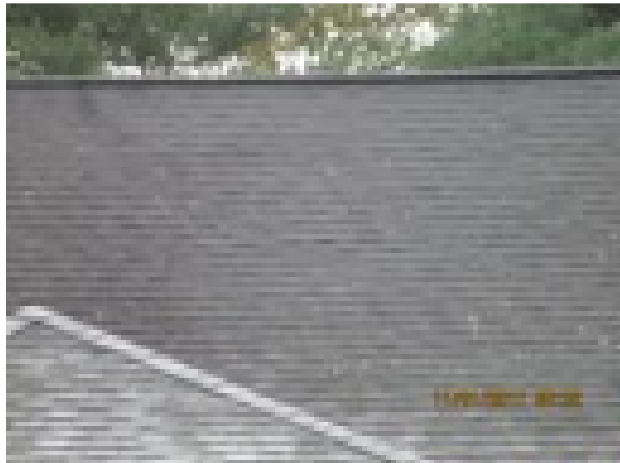
File name IMG_2169.JPG

Less than Satisfactory (Contractor advised)

Description: Damaged/lifting roof shingles are subject to repairs or replacement

Action: Recommend consult a qualified contractor
Required: for full evaluation/repairs or replacement.

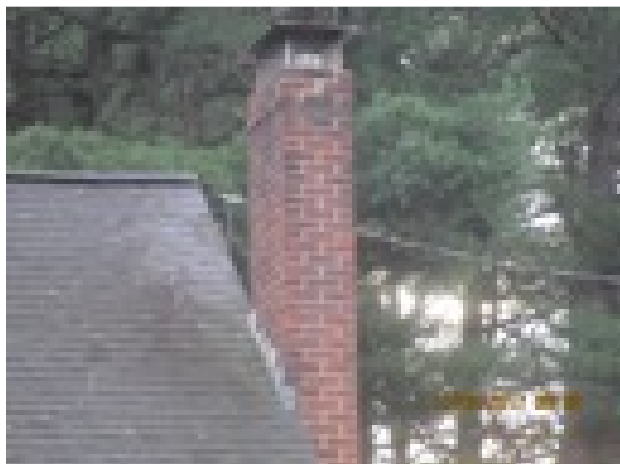
File name IMG_2170.JPG

Less than Satisfactory (Contractor advised)

Description: Missing mortar to areas of chimney noted and home owner stated chimney is serviced every year.

Action: Repairs noted, Obtain any and all
Required: statements, documents from all owner(s) /Town Officials/Permits/Contractor(s) who performs repairs and any and all warranties/Guarantees in writing.

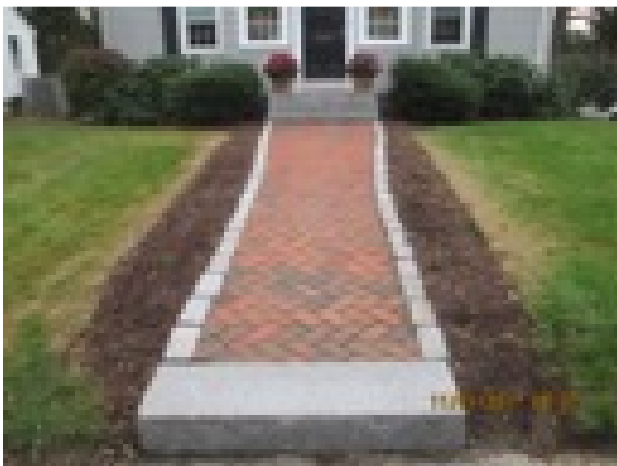
File name IMG_2174.JPG

Description: **Missing flashing between landing and front porch**

Action: Recommend consult a qualified contractor
Required: for full evaluation/repairs or replacement.

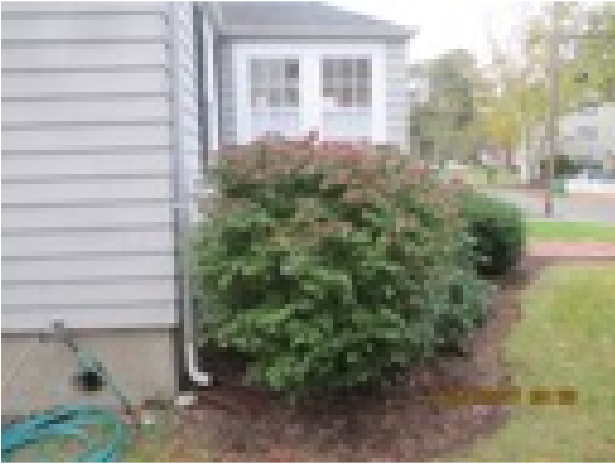
File name IMG_2182.JPG

Less than Satisfactory (Contractor advised)

Description: **Improper oil vent at foundation noted**

Action: Recommend consult a qualified contractor
Required: for full evaluation/repairs or replacement.

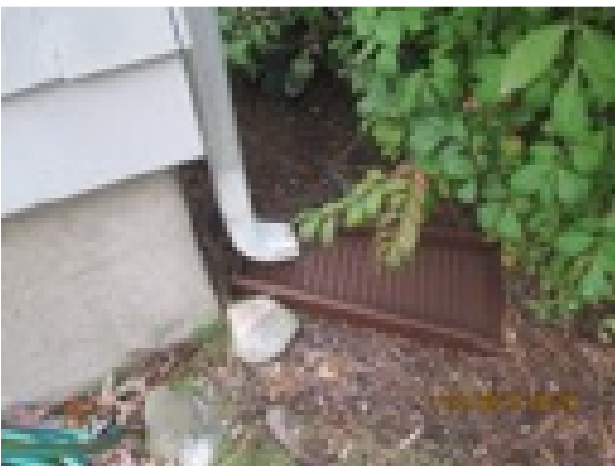
Less than Satisfactory (Contractor advised)

Description: **Missing caulking to trim noted**

Action: Recommend consult a qualified contractor
Required: for full evaluation/repairs or replacement.

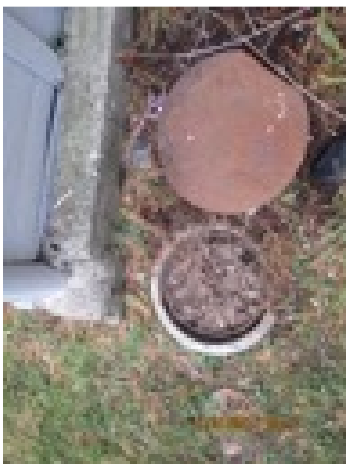
Less than Satisfactory (Contractor advised)

File name IMG_2218.JPG
Date of photo: 11/1/2017
Report Page: Exterior
Description: Abandoned garbage bin noted, recommended remove as needed
Action: Recommend consult a qualified contractor
Required: for full evaluation/repairs or replacement.

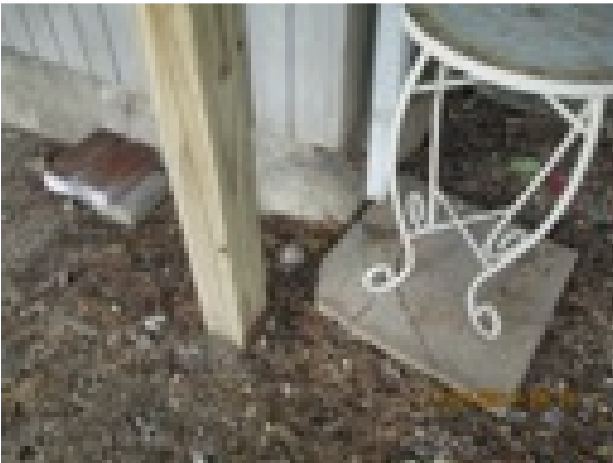
File name IMG_2242.JPG

Less than Satisfactory (Contractor advised)

Description: **Sidewall to earth contact with gaps and holes for rodents noted.**

Action: Recommend consult a qualified contractor
Required: for full evaluation/repairs or replacement.

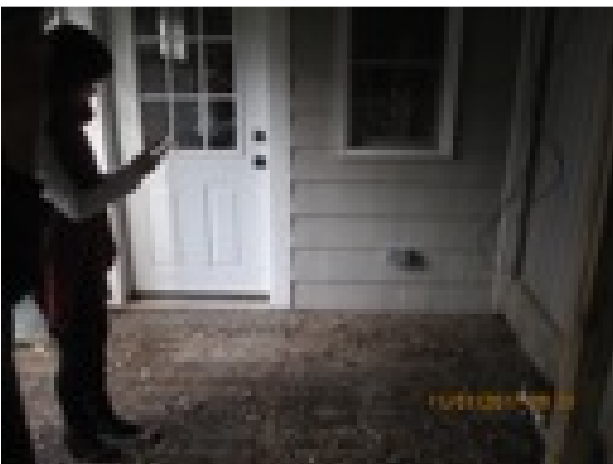
Less than Satisfactory (Contractor advised)

Description: **Missing flashing noted to area of decking**

Action: Recommend consult a qualified contractor
Required: for full evaluation/repairs or replacement.

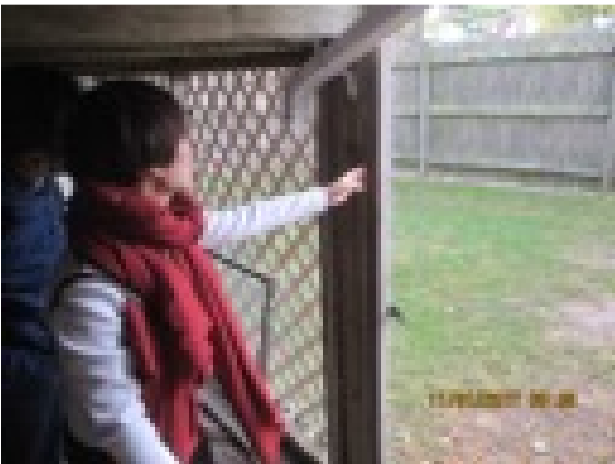
Less than Satisfactory (Contractor advised)

Description: **Damaged trim board noted**

Action: Recommend consult a qualified contractor
Required: for full evaluation/repairs or replacement.

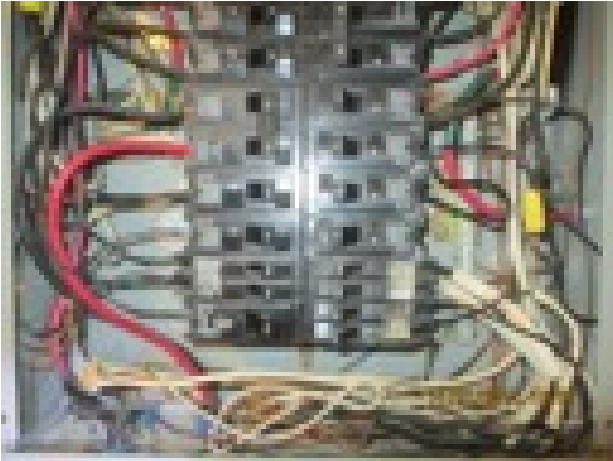
Unsatisfactory (Contractor required)

File name IMG_2343.JPG
Date of photo: 11/1/2017
Report Page: Electric System
Description: Evidence of water penetration noted

Action: Recommend consult a qualified contractor
Required: for full evaluation/repairs or replacement.

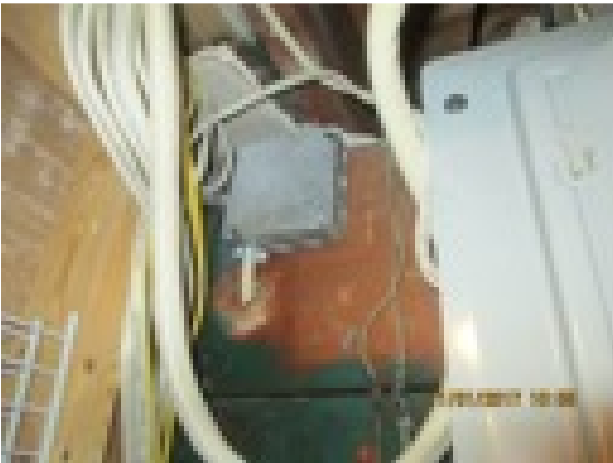
Unsatisfactory (Contractor required)

File name IMG_2345.JPG
Date of photo: 11/1/2017
Report Page: Electric System
Description: Cut disconnected wires noted

Action: Recommend consult a qualified contractor
Required: for full evaluation/repairs or replacement.

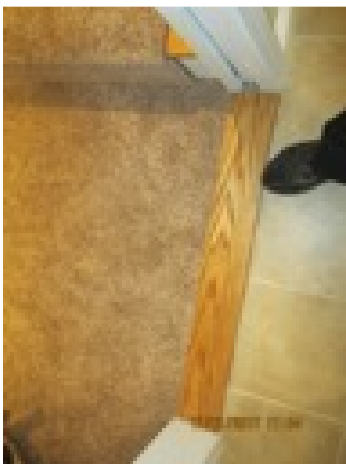
Less than Satisfactory (Contractor advised)

File name IMG_2354.JPG
Date of photo: 11/1/2017
Report Page: Basement
Description: Unleveled, dips, settled floors and Raised threshold is a trip hazard

Action: Recommend consult a qualified contractor
Required: for full evaluation/repairs or replacement.

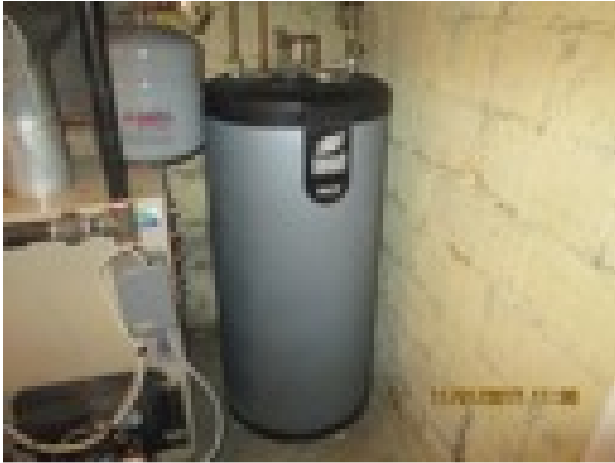
File name IMG_2356.JPG

Less than Satisfactory (Contractor advised)

Description: Pitting to supply pipes noted

Action: Recommend consult a qualified contractor
Required: for full evaluation/repairs or replacement.

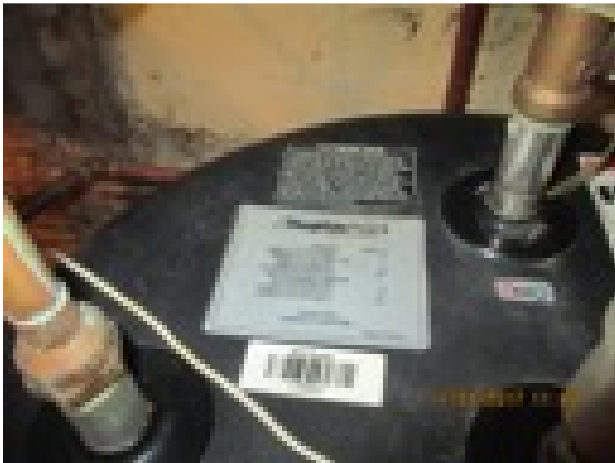
File name IMG_2357.JPG

Unsatisfactory (Contractor required)

Action: Recommend consult a qualified contractor
Required: for full evaluation/repairs or replacement.

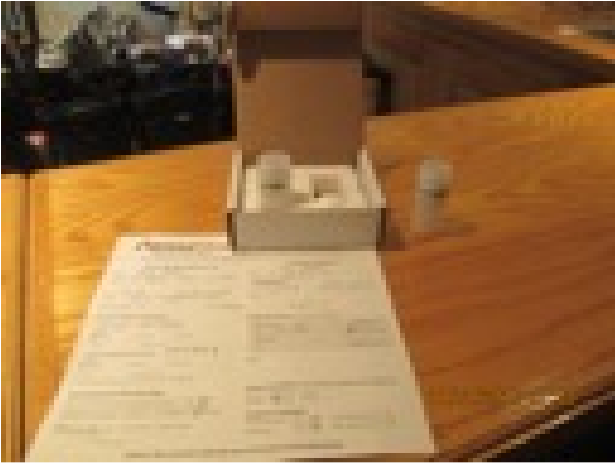
File name IMG_2360.JPG

Less than Satisfactory (Contractor advised)

Action: Recommend consult a qualified contractor
Required: for full evaluation/repairs or replacement.

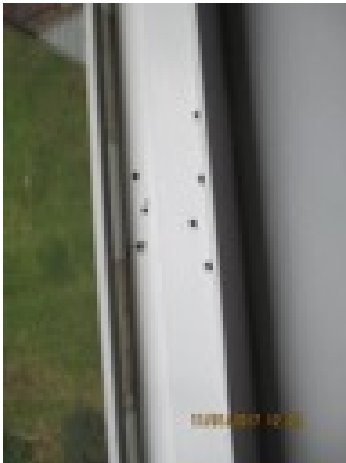
File name IMG_2379.JPG

Less than Satisfactory (Contractor advised)

Action: Recommend consult a qualified contractor
Required: for full evaluation/repairs or replacement.

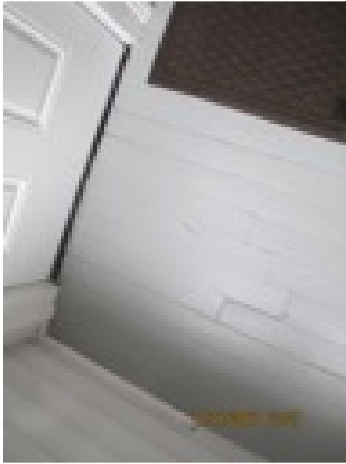
File name IMG_2410.JPG

Less than Satisfactory (Contractor advised)

Description: **Patched porch flooring noted**

Action: Repairs noted, Obtain any and all
Required: statements, documents from all owner(s)
/Town Officials/Permits/Contractor(s) who
performs repairs and any and all
warrantees/Guarantees in writing.

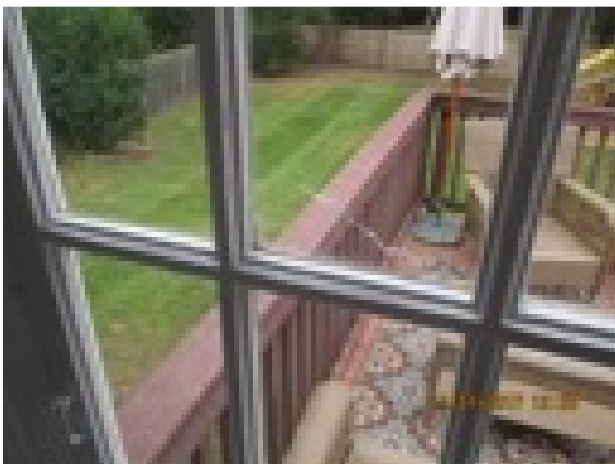
File name IMG_2412.JPG

Unsatisfactory (Contractor required)

Description: **Broken window pane requires replacement**

Action: Recommend consult a qualified contractor
Required: for full evaluation/repairs or replacement.

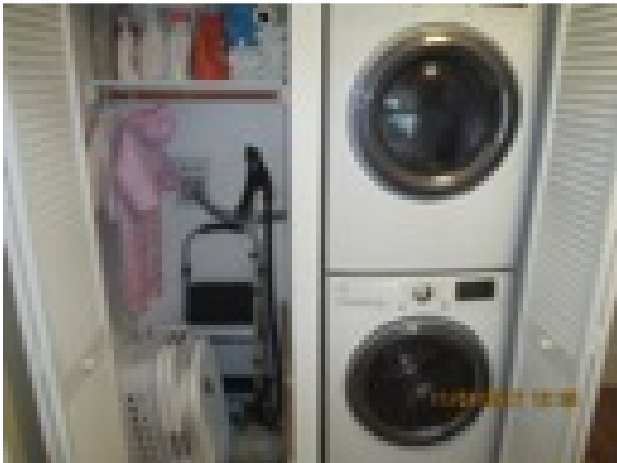
File name IMG_2428.JPG

Less than Satisfactory (Contractor advised)

Description: **Raised floor is a trip hazard nonted**

Action: Recommend consult a qualified contractor
Required: for full evaluation/repairs or replacement.
